Observations on Tornado Damage to Residential Structures in Bendigo

Mark Edwards , Xun Guo Lin and Neil Corby - Geoscience Australia

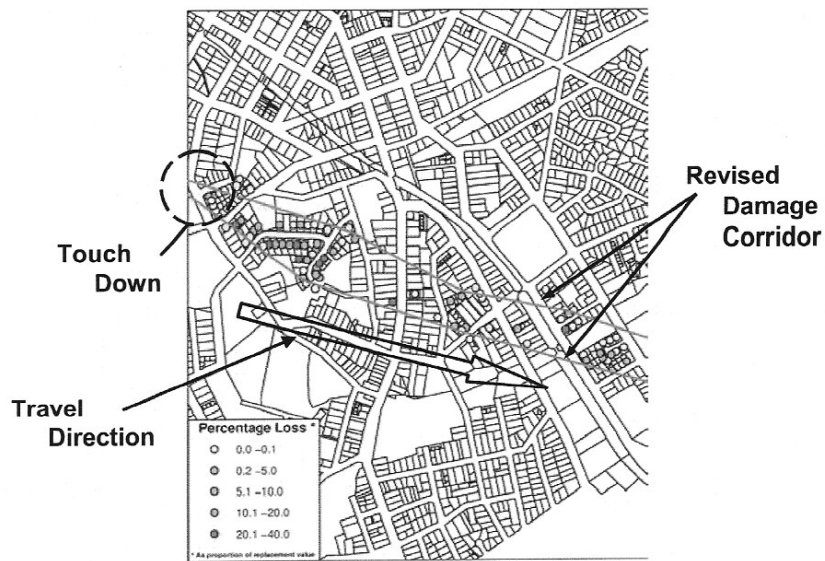
Figure 2:- Refined tornado damage corridor and damage levels.

The spatial distribution of the sustained financial losses permitted the tornado path to be more precisely defined. The corridor width that experienced the strong winds varied and the counter-clockwise spin of the tornado was particularly apparent in the Eaglehawk area (refer Figure 2). Within the tornado path 80 brick veneer homes were located with 37 damaged. Despite the small size of the data set the results were aggregated to obtain a single verification data point. Expressing the losses on a population basis the mean wind speed of approximately 45 m/s resulted in a mean loss of 4.7 % of the combined replacement value of the homes exposed.

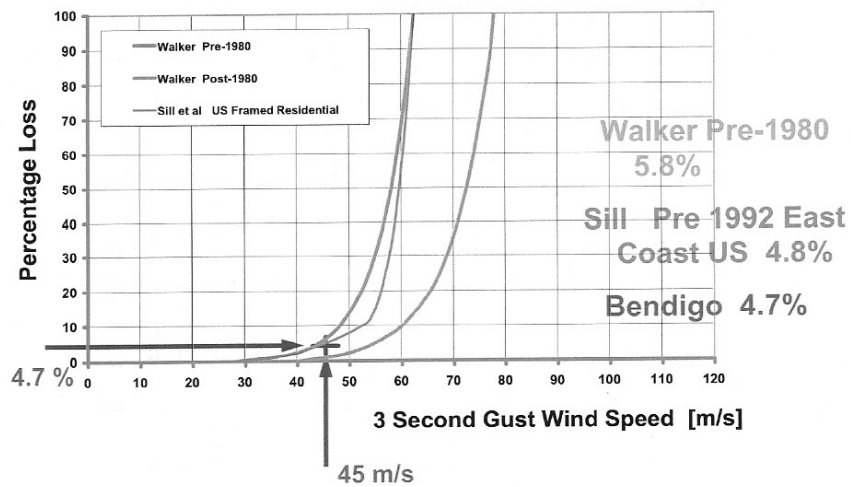
Figure 3:- Comparison of aggregated Bendigo damage to published vulnerability curves.

Several residential vulnerability curves are presented in the literature. The two curves proposed by George Walker for North Queensland residences are shown in Figure 3. Also shown in the figure is a curve developed by Sill for pre-1992 U.S. homes based on hurricane damage claims. The data point obtained from the Bendigo survey is further presented and lies very close to both the pre-1980 George Walker curve and that proposed by Sill.

The single verification data point suggests that George Walker's pre-1980 curve for North Queensland structures may also be representative of non-cyclonic brick veneer residential construction. However the significant limitations of data set size and the non-uniform nature of the wind field make the drawing of any firm conclusions difficult.
