# Water Spout Damage At Lennox Head

M.J. Glanville<sup>1</sup> and J.P. Quinn<sup>2</sup>

## 1. INTRODUCTION

A water spout swept through the coastal town of Lennox Head 3<sup>rd</sup> June 2010 causing extensive property damage. This paper documents observed damage and attempts to trace the path of the spout and quantify intensity of winds.

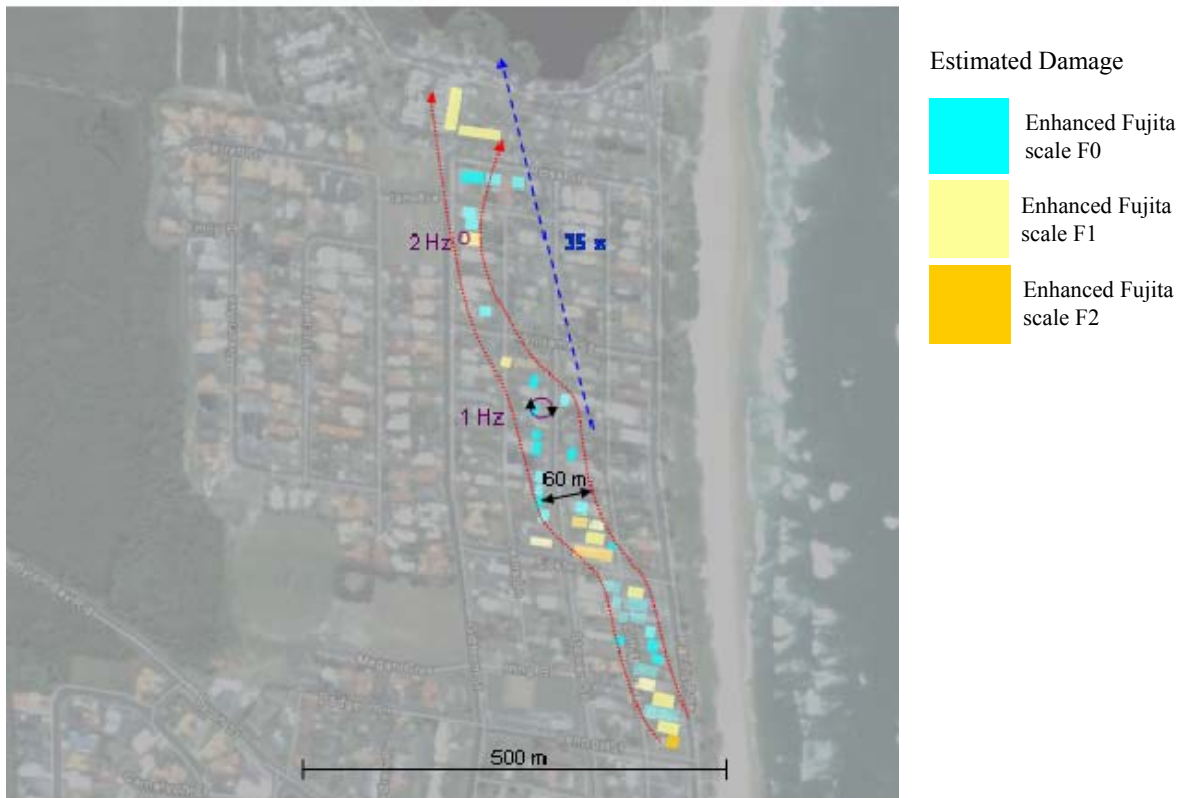
Fig. 1 Water spout path through Lennox Head 3<sup>rd</sup> June 2010 with recorded damage.

Fig. 1 traces the approximate path of the spout between landfall near the corner of Pacific Parade and Lennox Street then moving inland in a north-westerly direction over Stewart Street before losing intensity at Lake Ainsworth Caravan Park.

A photographic recording of the damage was obtained during a site inspection within hours of the storm by Quinn and also on 12<sup>th</sup> June 2010 by Quinn and Glanville. A summary of the damage sustained to each of the dwellings within the effected zone are shown in Fig. 1, ranked by the authors against the Enhanced Fujita scale (2006), Fig. 2.

The path of recorded damage is traced in red lines of Figure 1. Shattered windows and damaged cladding due to projectile impact was observed beyond this boundary.

m in 35 seconds (Fig. 1), i.e. an average velocity of 14 m/s. Thus velocities experienced in the path of the spout could therefore have been in the vicinity of 65 m/s.

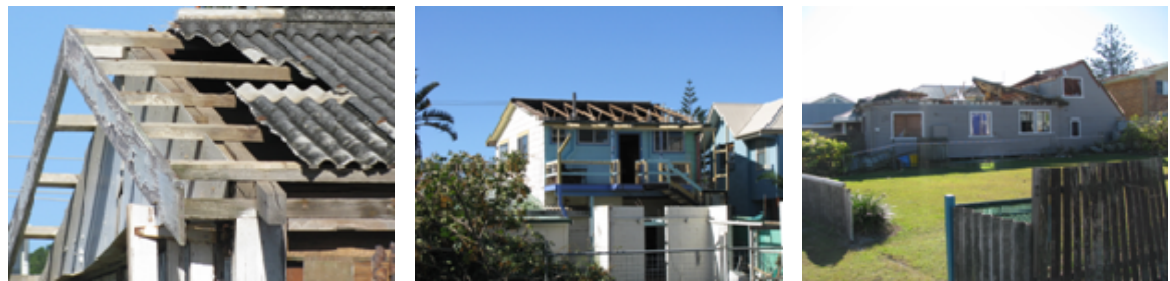
Fig. 2 Example Water spout damage at Lennox Head.

Of the 12 homes estimated to have sustained damage at Enhanced Fujita scales of EF1 and EF2, 7 were estimated to be of pre 1980 construction, and 5 of more recent construction. Of the 3 homes estimated to have sustained EF2 level damage, 2 appeared to be of post 1980 construction. Some photographic examples of property damage are provided in Fig. 2. Comparing the observed damage against the Enhanced Fujita Scale it could be estimated winds reached velocities of up to 60 m/s.

Enhanced Fujita scale EF0, 29-38 m/s    Enhanced Fujita scale EF1, 39-49 m/s    Enhanced Fujita scale EF2, 49-60 m/s
