Damage to low rise buildings during Tropical Cyclone Yasi

D.J. Henderson¹, G.N. Boughton^{2,3}, J.D. Ginger¹, J.D. Holmes³, G.R. Walker³, C.J. Leitch¹,
 L.R. Somerville¹, U. Frye¹, N.C. Jayasinghe¹, P.Y. Kim¹ and G. Stark¹

¹ Cyclone Testing Station, James Cook University, Townsville

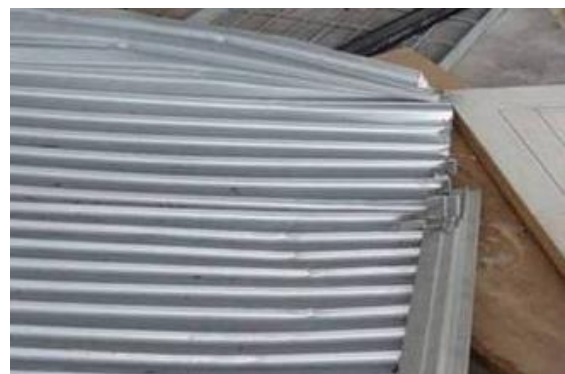
Figure 4 shows a roller door with wind locks that has remained attached to the door guides. Unfortunately the guides were not adequately fixed to the wall. Where wind locks are active, wind loads induce large catenary forces within the door and its supports. These loads need to be taken account of in the design of connections and frame.

Figure 4: Roller door guide failure

The roller door design standard AS/NZS4505 does provide design pressures for cyclonic regions. It is not referred to in the BCA so is not a regulatory requirement. Even so, since the doors are a part of the building envelope they must be designed and installed to resist the applied wind loads.

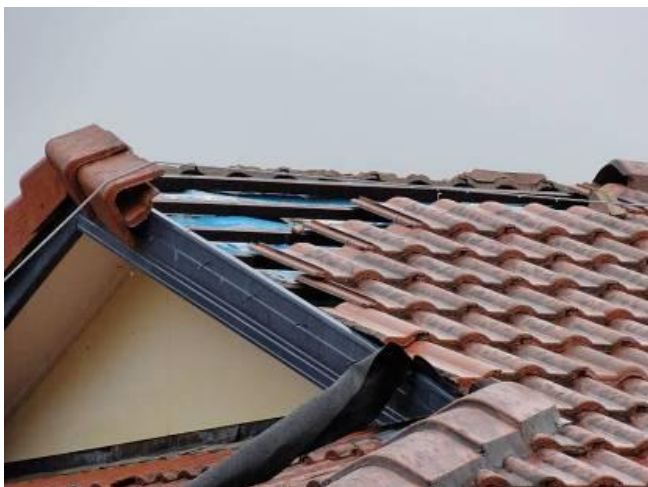
For Post-80s construction, damage to tile roofs was overrepresented when compared to other forms of roofing. Figure 5 shows the poorer performance of tiles compared to sheet roof for various AS4055 wind speed classifications (associated with exposure and topography). Failure modes of the tiles were loss of ridge capping (both apex and hip tiles), loss of tiles near gable ends, and cut tiles associated with hips. On most houses that had lost ridge capping, no mechanical fixings such as clips or screws on the ridge tiles were observed (Figure 6). The fixing method appeared to be flexible pointing adhesive. Examples were noted of failed or dislodged tiles that had clips attached to battens. It is unknown if the clips were correctly engaged with the tile prior to the wind loads or if the tiles disengaged during the wind loading. The dislodgement of the ridge or other tiles generally led to additional damage to the tile roof and to adjacent structures through wind-borne debris. The study has shown that improvement is required in fixing practices of roof tiles.

Figure 6: Failure of ridge capping

- Tile roofs: Revisions were proposed for AS2055 to no longer allow flexible pointing as a means of fixing ridge tiles and requires part tiles to be mechanically fixed to battens.

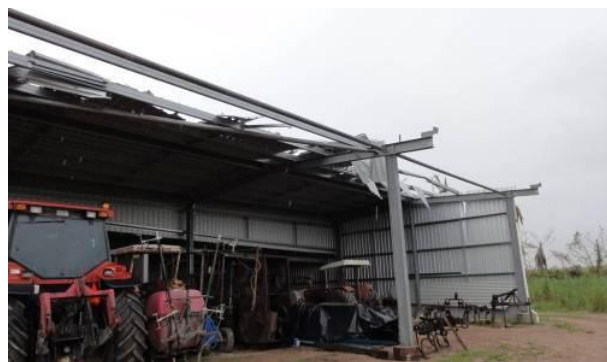
inside of the roof and walls with failure of roller door; Structural damage to sheds with two or three walls caused when the winds aligned with the shed opening direction and resulted in buckled purlins and cladding loss as shown in Figure 7; Failure of windward walls with buckling of purlins and no compression bracing; Inadequate connections with observed missing bolts or screws; Corrosion of purlins as well as connections of major framing elements; And inadequate footing details with complete shed frames being lifted clear of the ground with resulting large impact damage on adjacent buildings.

Figure 7: Buckling and loss of purlins with cladding

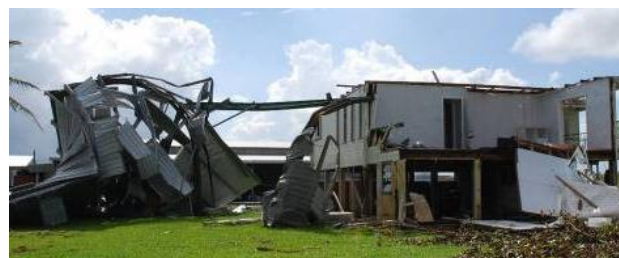
The damage caused by shed failure can be compounded if they are located adjacent to other structures. Catastrophic failures can lead to the entire structure impacting adjacent buildings which are otherwise intact, as shown in Figure 8. This type of wind borne debris is not considered in the design of structures.

Figure 8: Failure of shed and impacted house
