Windstorms in Victoria and Southern NSW – March 21, 2013

J.D. Holmes¹

Abstract

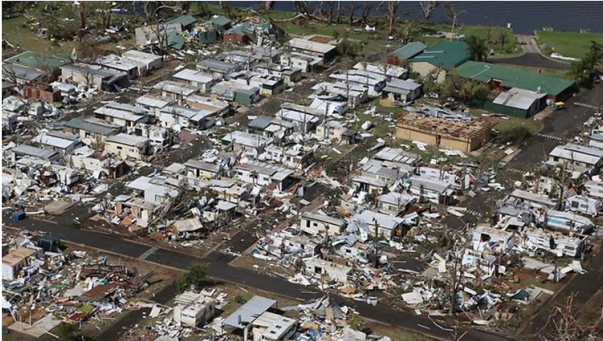
Figures 3 and 4 show images from the Denison County Park apparently taken the day after the event. These figures indicate damage reminiscent of tropical cyclones and probably wind gust speeds of 55+ m/s.

Figure 3. Aerial view of damage to the Denison County caravan park, Mulwala

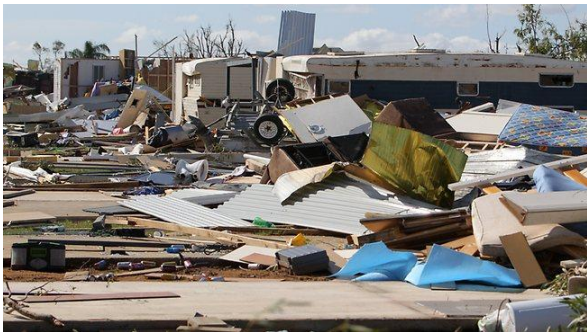
Figure 4. Close up view of damage to the Denison County Caravan Park

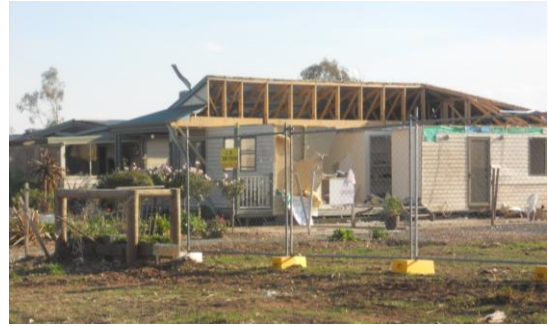
Figures 5 to 9 show damage at the Sun Country Holiday Village taken some two weeks after the event. There is a mixture of caravans, attached annexes, separate cabin units, and boat storage units on this site. The worst damage appeared to occur at the north-west corner of the site, from which reportedly complete caravans were blown towards the north.

Figure 5. Roof damage – Sun Country Holiday Village, Mulwala

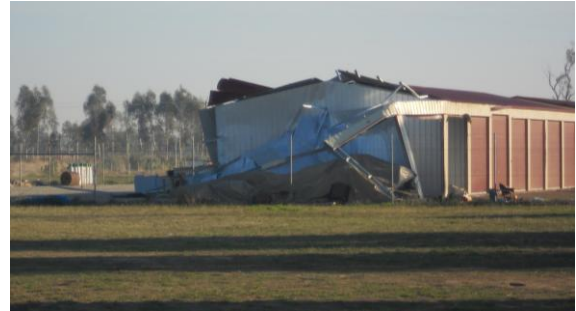
There were a large number of boat storage sheds on that site (Figure 6) with large roller doors, which, as expected, were not able to resist the wind pressure when on a windward wall. On the other hand some recently-constructed residential units seem to suffer no damage (Figure 7).

Figure 6. Boat storage sheds – Sun Country Holiday Village, Mulwala

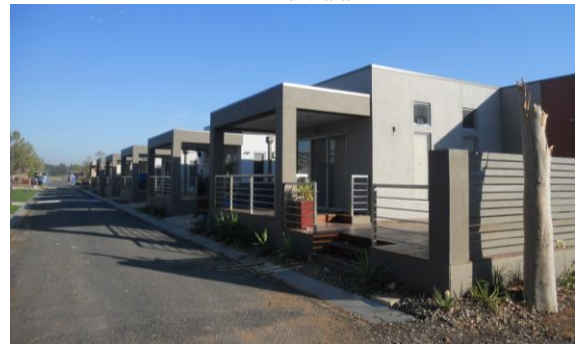
Figure 7. Undamaged holiday units – Sun Country Holiday Village, Mulwala

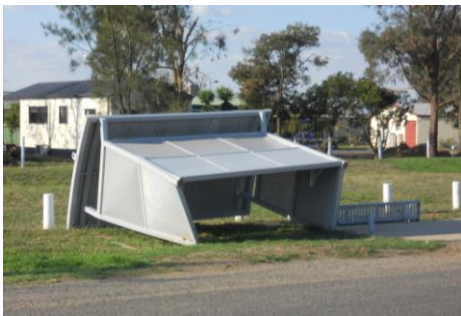
Some idea of the of the minimum level of wind speeds that occurred at this site can be obtained from a bus shelter that apparently was lifted by the wind and travelled several metres (Figure 8), and a substantial steel light pole (approximately 5 metres long, with a square hollow section cross-section 75mm square and steel thickness of about 2 mm) that was completely buckled at the base (Figure 9).

The minimum gust wind speed required to lift the bus shelter, resisted only by the gravitational force, can be estimated by:

$$V_{min} = \sqrt{\frac{2mg}{\rho AC_L}} \quad (1)$$

Taking $m = 350\text{Kg}$, $A = 3.6 \times 1.2 = 4.3 \text{ m}^2$, and $C_L = 1.5$, gives $V_{min} \cong 30\text{m/s}$. This calculation, of course, assumes no structural resistance to the uplift force, so the actual wind speed at the time of failure could have been considerably in excess of 30 m/s. However, it should be noted that this structure was probably 200-300m from the centre of the tornado path

Figure 8. Bus shelter – adjacent to Sun Country Holiday Village, Mulwala

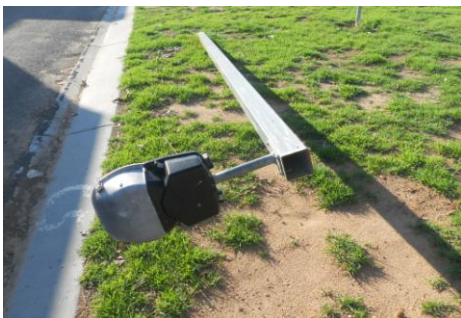
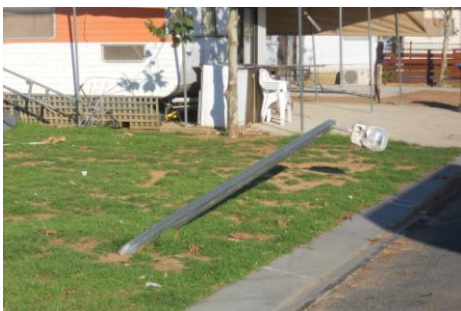
The average wind speed required to fail the light pole shown in Figure 9 (a) and (b), can be estimated approximately assuming the section is made from steel with 350 MPa yield stress:

$$V_{fail} = \sqrt{\frac{2M_{all}}{\rho \left[\frac{bL^2 C_d}{2} + LAC_D \right]}} \quad (2)$$

where M_{all} is the allowable moment for the section – estimated as 4.7 kN.m. The length, L , is 5 metres, $b = 0.075\text{m}$, C_d is 2.0 for

the square cross section pole, C_D is about 1.0 for the light, and $A \cong 0.03 \text{ m}^2$. Then Eq. (2) gives $V_{fail} \approx 62 \text{ m/s}$.

This may be a not unrealistic value, given that part of the site was close to the centre of the tornado path.

Figure 9. Buckled light pole – Sun Country Holiday Village, Mulwala

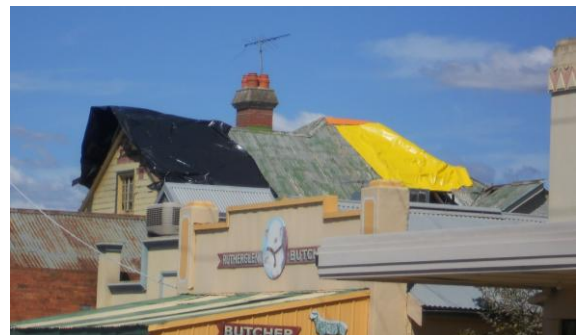
The damage in Rutherglen (Figure 11) was restricted to older buildings at the eastern end of the town, and to some winery buildings further east. There was no damage in the town of Euroa itself, but a service station on the Hume Freeway sustained some damage, although relatively superficial. (Figures 12 and 13). It is likely that these two events were local downbursts unrelated to the Mulwala tornado, except they were created on the same frontal system (Figure 1).

Figure 11. Roof damage – Rutherglen, Victoria

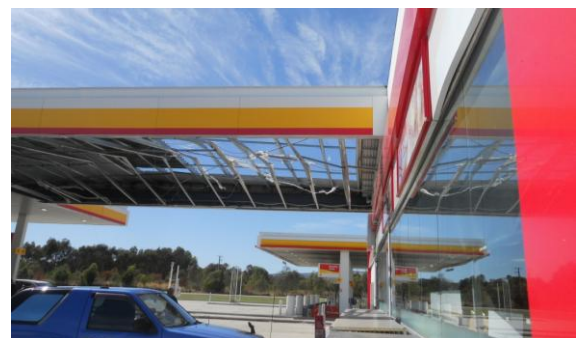
Figure 12. Soffit and canopy damage – Shell service station, Euroa, Victoria

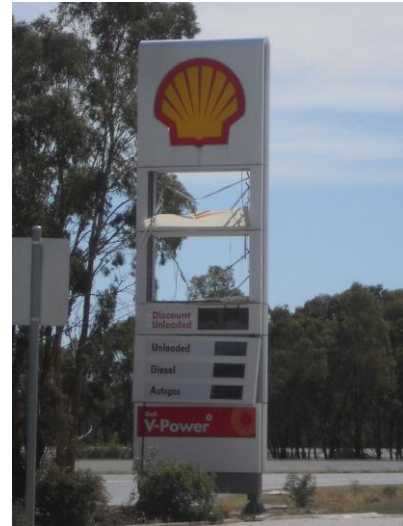
Figure 13. Panel damage – Shell service station, Euroa, Victoria
