Damage surveys following the Hobsonville Tornado in Auckland and Tropical Cyclone Evan in Samoa.

R. Turner¹, R. Paulik¹, G. Smart¹, J Bind¹, S. Gray¹, E. Yang¹, L. Asora², M. Leiofi², and R. Flay²

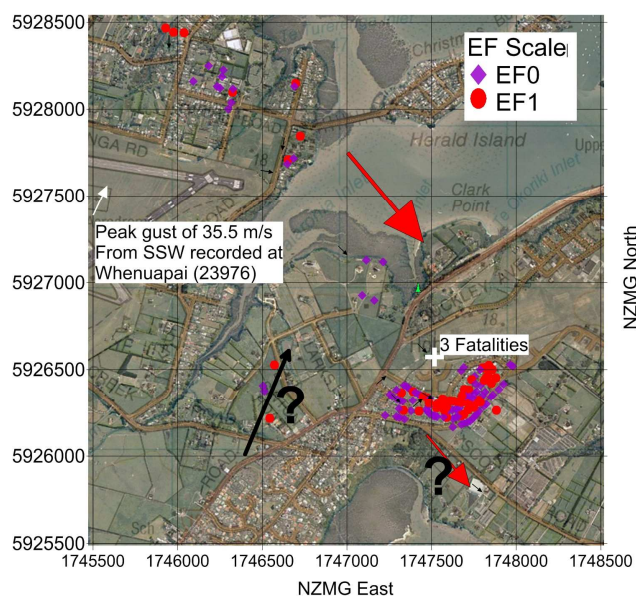
Estimates of the tornado strength based on the Enhanced Fujita scale were made and mapped (see Figure 5) and along with the wind observations a probable track of the tornado overlain were used to create a gridded wind-field ($\Delta x=20$ m), and applied to an

Figure 5. Plot showing location of surveyed properties in Whenuapai (NW section) and Hobsonville (SE section) which suffered varying degrees of damage and associated EF scale rating. The location of the school construction site where the 3 fatalities occurred is marked by the white cross. The red arrows show the general direction of movement of the storm.

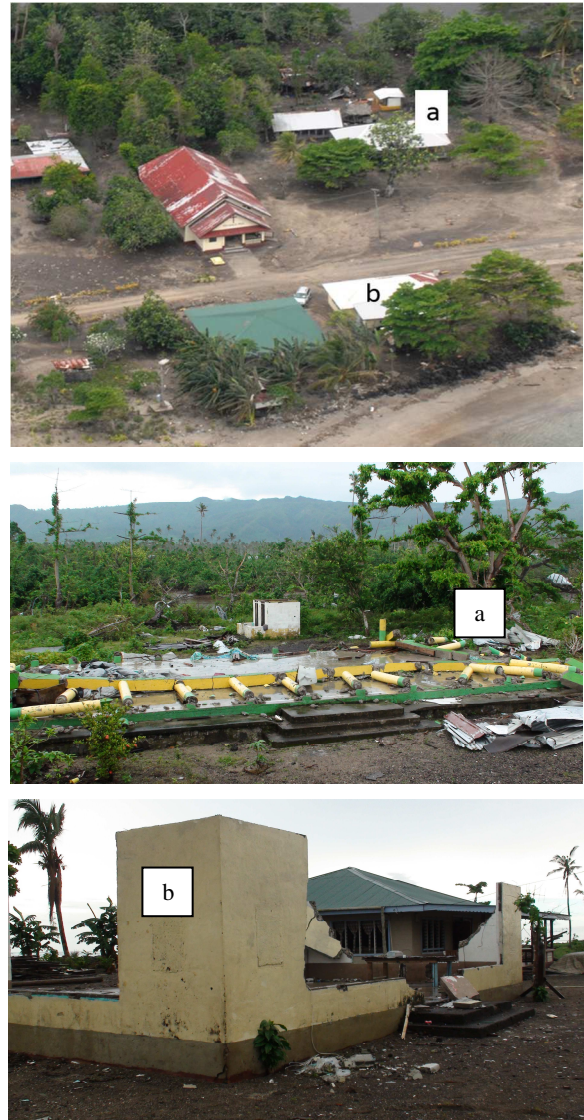
Figure 8. Photos of part of Tafitoala village that suffered wind-damage in TC Evan. The upper photo is from an aerial reconnaissance mission taken after the September 2009 Tsunami. The bottom panels show extreme damage to buildings after TC Evan. The middle panel is of the fale (sheet metal roof, reinforced concrete pillars on slab - damage state 5) at position “a” in the upper photo, the bottom photo is of the church meeting house (sheet metal roof, concrete cladding large openings on slab – damage state 5) at position “b”. Note, the undamaged dwelling (minor roof damage only) adjacent which was occupied during the cyclone.

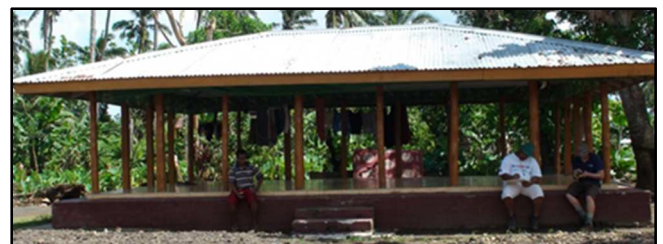
Figure 9. Typical Samoan Residential Fale, These buildings are a single storey open air with timber (or reinforced concrete) pylons connecting the roof structure with concrete slab or timber (piles) floor. Other typical features include a sheet metal or thatched roof.

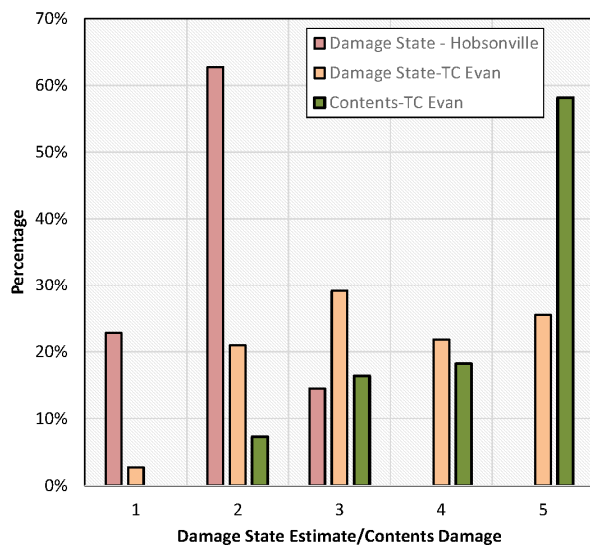
In total, 143 properties were surveyed of which 112 were in either damage state 2 or 3 (See Figure 10). The main area of damage occurred in a NZDF housing estate with many buildings of the same age (1960's) and construction (weatherboard single story, with either tile or sheet metal roofs) Photos of properties and observations/estimates of the following building attributes were recorded; gps coordinates (NZTM), address, use, number of storey's, wall cladding, roof cladding, pitch and geometry, percentage of wall openings occupied by openings, age, eave width, skylights (no.), damage to walls, roofs, upwind exposure, openings, debris impact, and water damage. A follow-up postal survey on content losses, displacement and business disruption is underway. Overall, the damage and wind-speeds were assessed as being much less severe than for Oakura, Taranaki 2007 which was EF2.

About 50% of buildings had damage states 4 or 5, i.e. irreparable or totally destroyed, and 75% had content losses exceeding 50%, (see Figure 10). Like Hobsonville much of the contents damage was due to water damage. Generally, “new” well built houses had little roof or structural damage but these still tended to experience water-ingress and this resulted in some loss of contents, mostly rated at <10%, but occasionally 10-50%.

Figure 10. Distribution of Damage State and Content loss estimates due to wind (and water ingress) for the 110 damaged properties surveyed in Tafitoala, Si’umu, and Mulivai, and for the 143 properties surveyed in Hobsonville (Damage state only shown). Damage state categories are; 1=Light non-structural, 2=Minor non-structural, 3=Moderate-structural repairable, 4=Severe/structural irreparable, 5=Collapse. Content damage classes are; 2=<10%, 3=10-50%, 4=50-80%, 5=>80%.
