Fastener Pull-out Tests to Determine Threshold Values for Roof Failure Modes Observed After Typhoon Haiyan in the Philippines

J.Y. Hernandez Jr.¹, H.O. Bisa¹, R.E.U. Longalong¹, R.M. Suiza¹, and C. Orozco¹

Abstract

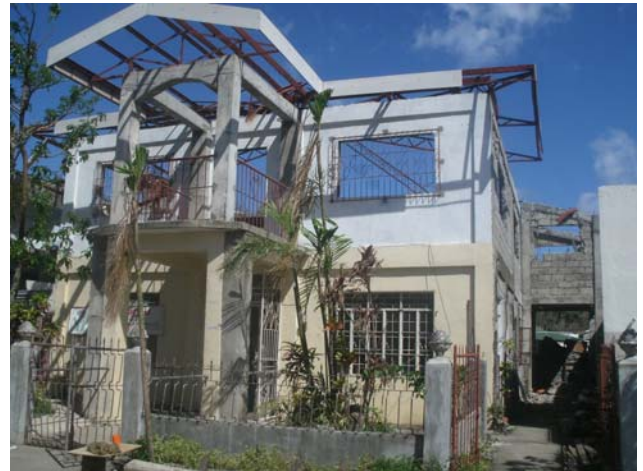
A joint damage survey was conducted by the Institute of Civil Engineering - Philippine Institute of Civil Engineers - Japan Society of Civil Engineers (ICE-PICE-JSCE) in Leyte and Samar islands after Haiyan. Almost all buildings lost a part of their building envelope, especially roofs. Figure 1 shows a two-storey reinforced concrete building with damage to hip roof truss, complete loss of G.I. sheets, and damage to windows, walls, and doors. Figure 2 shows typical damage to a single-storey reinforced concrete residential house with damage to gable roof truss, complete loss of G.I. sheets, and damage to windows and doors.

Figure 1. Typical damage to a two-storey reinforced concrete building (photo from ICE-PICE-JSCE Joint Survey).

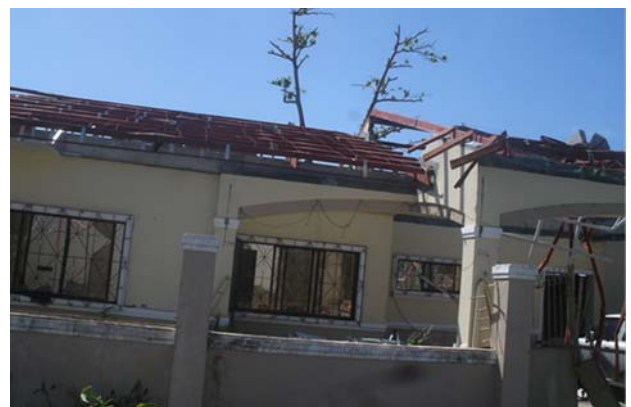
Figure 2. Typical damage to a one-storey reinforced concrete residential house (photo from ICE-PICE-JSCE Joint Survey).

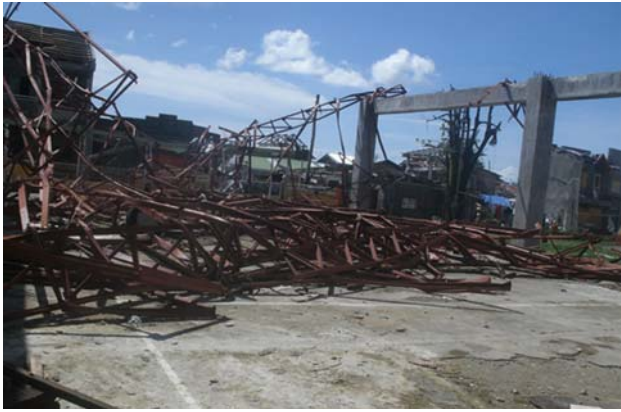
Figure 3. Collapsed Steel roof of a multi-purpose covered court (photo from ICE-PICE-JSCE Joint Survey).

Figure 3 shows the complete collapse of the steel roof of a covered court multi-purpose hall; there was a complete loss of all G.I. sheets. Figure 4 shows the damage to a Concrete Hollow Block (CHB) building with wooden roof. The roof framing is damaged, and there is a complete loss of the roof cover and purlins, doors, and windows. Figure 5 shows the damage to a

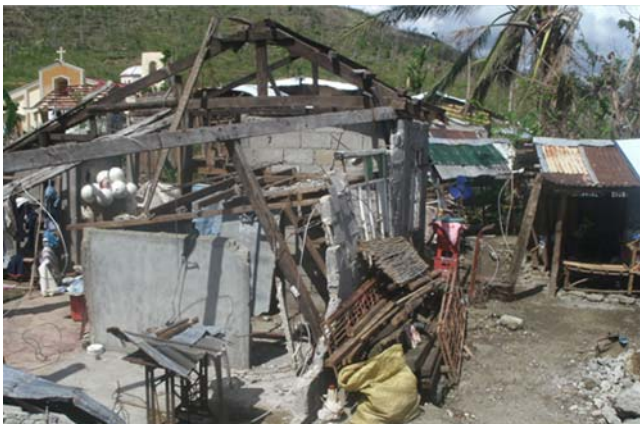
Figure 4. Typical damage to a one-storey CHB residential house with wooden truss (photo from ICE-PICE-JSCE Joint Survey).

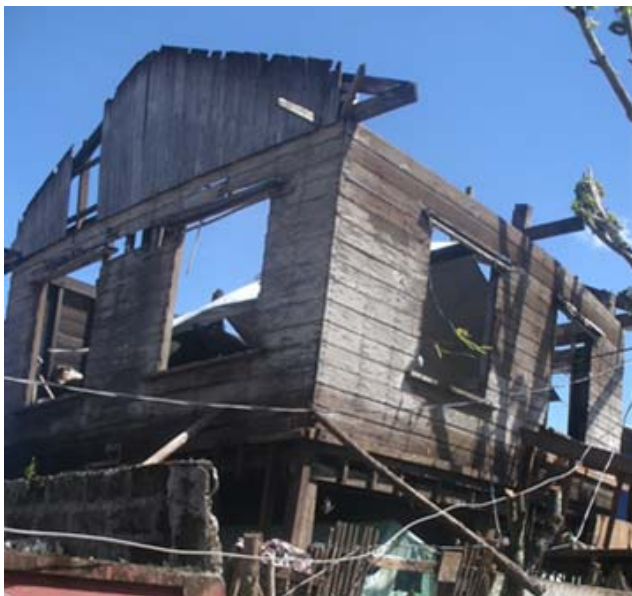
Figure 5. Typical damage to a two-storey wooden residential house (photo from ICE-PICE-JSCE Joint Survey).

two-storey wooden house with partial loss of roof trusses, complete loss of purlins, G.I. sheets, and windows.
