Cyclone Vance – Exmouth 1999

G N Boughton (Curtin University of Technology)

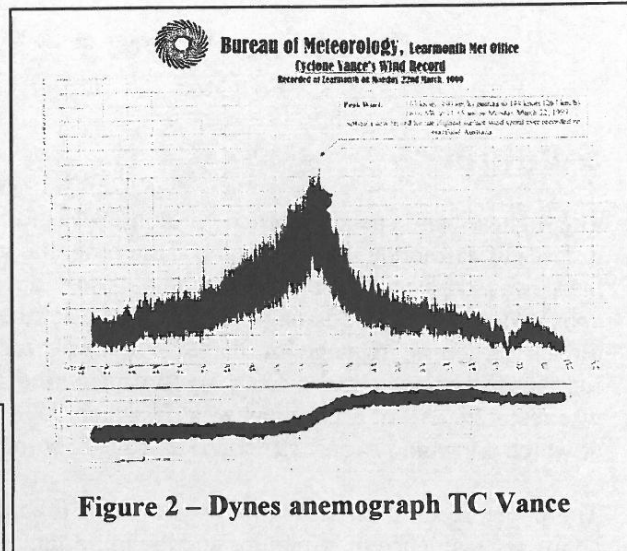
Figure 2 – Dynes anemograph TC Vance

A Dines anemometer at Learmonth airport recorded wind speeds during the passage of Tropical Cyclone Vance on 23rd March 1999. The characteristics of the wind speed are as follows:

- Maximum gust wind speed is 267 km/hr (75 m/s).

- The build up in wind speed took place gradually in Exmouth from 0300 WST to 1030 WST. This is consistent with the radar image which showed intense activity in the leading edge of the tropical cyclone.
- After the passage of the eye wall, the wind speeds dropped more quickly.
- Damage observations suggest that most of the town experienced wind speeds in the range 220 km/hr to 250 km/hr.

- The recorded maximum wind speed in Tropical Cyclone Vance is 87% of the design ultimate wind velocity for region D in the Australian Wind Loading Code (AS 1170.2).
