FIELD DAMAGE SURVEY OF THE DUBBO, NSW, WINDSTORM OF 6TH JANUARY, 2001

BY JOHN STEHLE¹ AND DAVID HENDERSON²

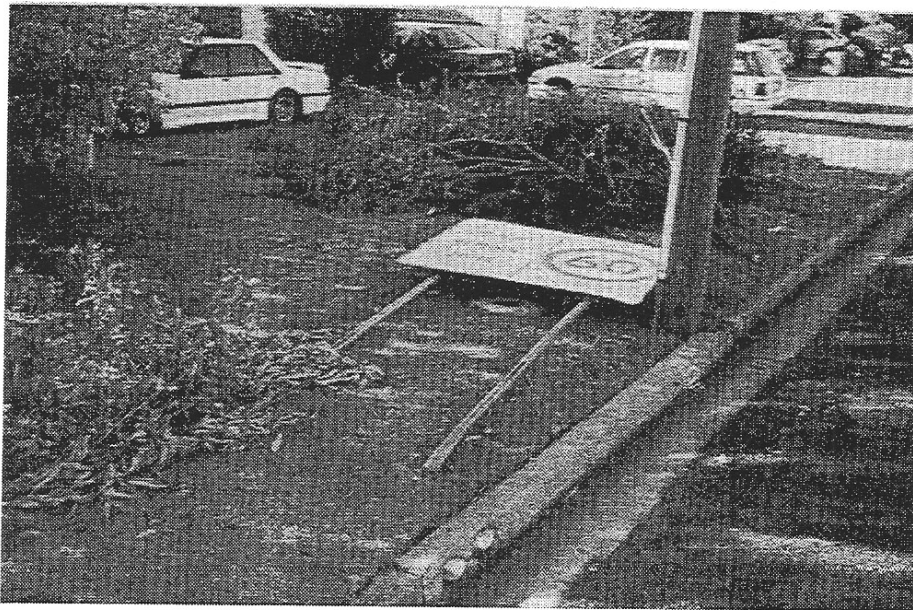
Due to a lack of wind speed data, an attempt was made to estimate the wind speed by considering the wind speed required to bend over street signs. Two parallel signs in Wheeler's Lane, within the worst affected area, were found to be suitable for such a calculation. Both signs faced the South, which was the predominant source of the wind direction, but only one sign was bent over in flexure (Figure 2). The other, stronger sign had not bent at all. By considering the estimated flexural strength and the measured geometry of the signs, the peak gust speed at 10 m height is estimated to have had a lower bound of 90 km/h and an upper bound of 150 km/h. Based on these calculations and estimates by local emergency response personnel and engineers, the peak gust wind speed is estimated to be in the order of 140 km/h, or 40 m/sec.

Figure 2: A bent over sign in Wheeler's Lane – obviously the speed limit was exceeded

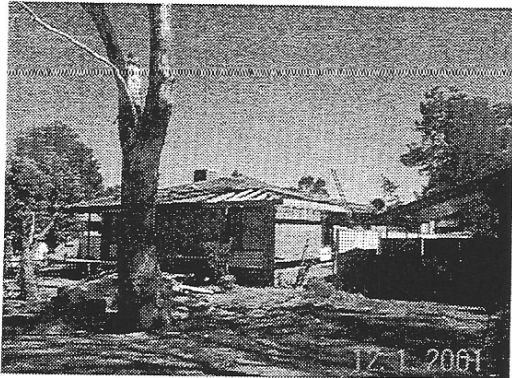
Figure 3: Debris damage to roof cladding and structure from fallen tree branch (Myall St)

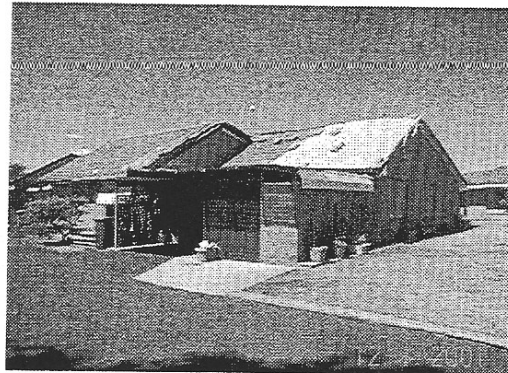
Figure 5: Damage to tile roof due to wind suction at leading roof edges (Cunningham St)

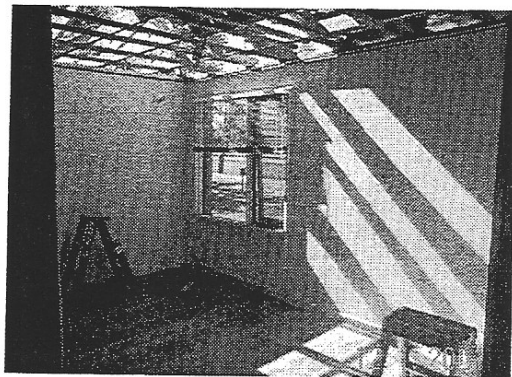
Figure 4: Internal water damage to house shown in Figure 3

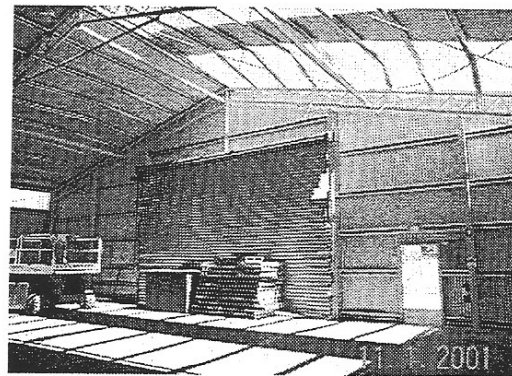
Figure 6: Debris damage to roller door allowed internal pressurisation and subsequent roof damage (Douglas Mawson Rd)

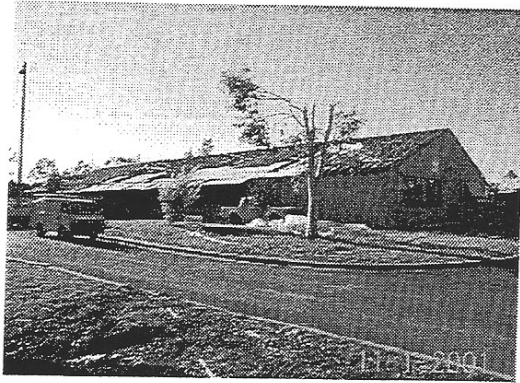
Figure 7: Complete damage to TAFE College building roof cladding (Myall St)

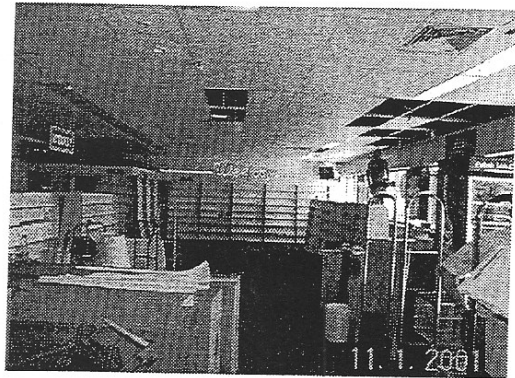
Figure 8: Internal water damage to Orana Mall shopping centre due to poor drainage

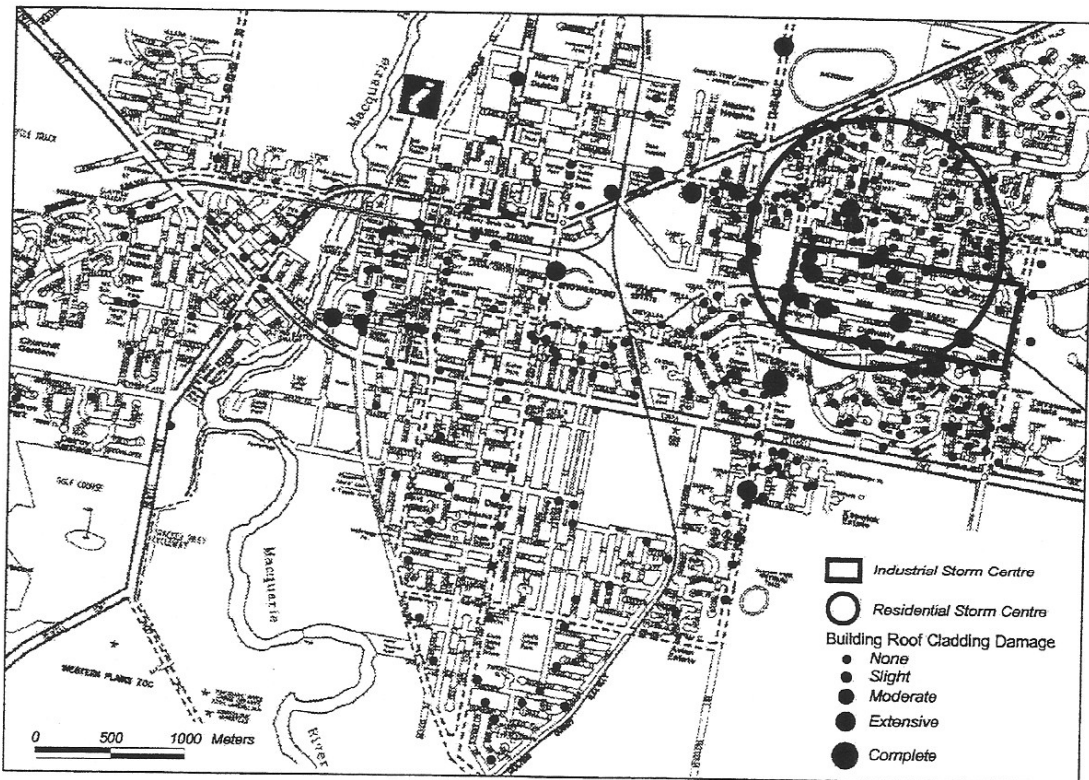
Figure 9: Distribution of damage to roof cladding

Some noteworthy comparisons have been generated with regard to residential and commercial construction. In the severely affected residential area (residential storm centre in Figure 9), approximately 5% of the 800 or so buildings with tile roofs had roof damage. This damage was approximately evenly divided between the slight and moderate damage states. Only one residential building with a metal roof was observed to have damage, even though such buildings make up approximately 13% or 120 buildings of the residential building stock (approximately 920 buildings in total) within the area considered. Hence, tile roofs on residential structures appear to be more vulnerable than metal roofs and there may be justification in improving performance standards for tile roofing. Failure of ancillary elements of housing, such as fences, garden sheds and awnings, added to the wind driven debris field causing further property losses.

Approximately 50% of the 40 or so industrial buildings in the most severely affected industrial area (industrial storm centre in Figure 9) suffered some damage. The damage was mostly to roof and wall cladding and to roller-doors, with the damage states ranging from slight to extensive. Overall, industrial buildings performed worse than residential structures. Modern, engineered construction failed at wind speeds estimated to be less than design speeds. This could be attributed to a lack of conservatism in engineering design practice. In particular, the assumption that buildings would remain nominally sealed is a risky one with the high incidence of window and roller door failures observed.
