Water Penetration into Buildings with no Structural Damage during High Winds

G Boughton¹, D Falck¹ and D Henderson¹

¹Cyclone Testing Station, James Cook University,
Townsville, Queensland 4811, Australia

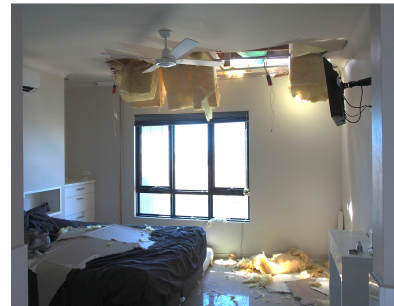
Once water breached the building envelope, it moved through wall and ceiling spaces, pooled on ceilings and ran down wall linings, affecting furniture, floor coverings and belongings. In some cases, plasterboard ceilings collapsed under the weight of the water during the event (Figure 1). As the ceiling and walls act as structural diaphragms, there is potential for structural performance to be compromised by loss of ceilings.

Figure 1. Water damage to linings

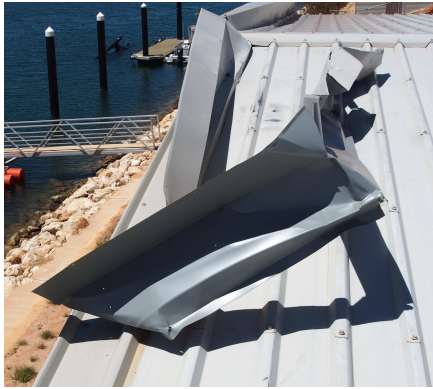
Loss of flashings due to wind loads where flashing was inadequately fastened allowed significant amounts of water into the building. As flashings were often used above the ceiling, the loss of the flashing caused damage to ceilings.

Figure 3. Loss of barge flashing

Many flashings are located in areas affected by high local pressure factors, but even the most comprehensive installation manuals (e.g. Lysaght, 2014, Department of Building and Housing, 2011; Standards Australia, 2012) provide limited guidance on fastening. Flashings must be securely fixed with screws (not pop rivets) to both sides of the gap.

- detail on anchorage of flashings, in particular anchorage of barge flashings to both barge and roof surfaces;
- improved water-tightness of flashings at the top of roofing surfaces (apron flashings, ridge flashings and valley gutters).

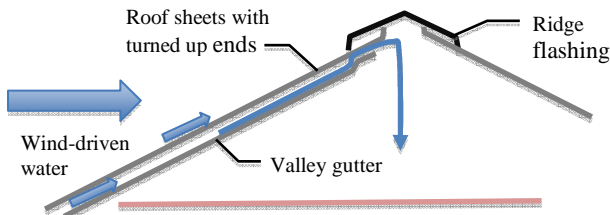
Even where flashings remained intact, in some cases water was driven under the flashing and into cavities. This included water driven under apron flashings into wall cavities on second storeys, water driven up walls under barge flashings and water driven up valley gutters under ridge flashings. Figure 4 illustrates water being driven up a valley gutter, under the roof sheeting at the top, and overflowing the edge of the valley gutter sheeting into the roof space.

Figure 4. Water driven up valley gutter under ridge flashing

Flashings and drainage paths such as weep holes in windows are designed to divert downward moving water away from gaps in the building envelope. At high wind velocities, the rain approaches the building nearly horizontally. The airflow around and over a building at winds near the serviceability limit state can drag water upwards and over the building envelope (Figure 4).

Flashings generally require gaps for expansion and isolation of metal elements. In places where water can accumulate at the flashing, these gaps may need to be sealed. Some builders in Exmouth had used well-secured compressible foam strips at the top of valley gutters, under ridge flashings or under apron flashings (Figure 7) to prevent wind-driven rainwater entering roof spaces and damaging ceilings.

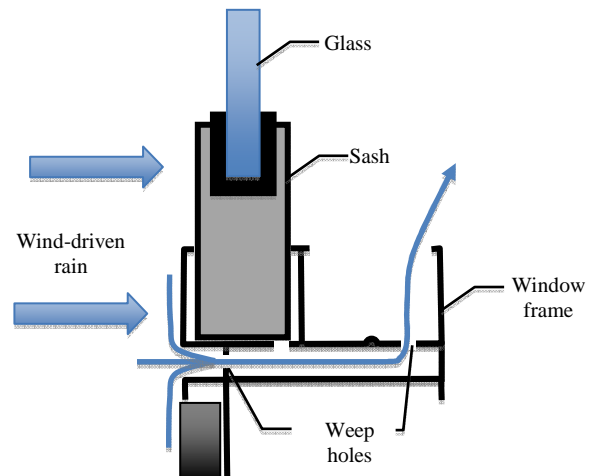
Weep holes are usually located in recesses in the window frame that can allow water that is running up or down the window to accumulate around the weep holes. Figure 5 shows that on windward walls, horizontally driven rain is forced through the weep hole by the air pressure (in the opposite direction to its intended path). Water bubbling through the weep hole, as shown in Figure 2, is consistent with water entrained in moving air.

Figure 5. Water driven through weep holes in windows

Two home-owners said that they had taped up the weepholes in their sliding windows as part of their preparation for the approaching cyclone. They reported that very little water entered their homes through windows during TC Olwyn. However, a more effective option is to detail weep holes to allow water to drain out of the building, but prevent air movement into the building:

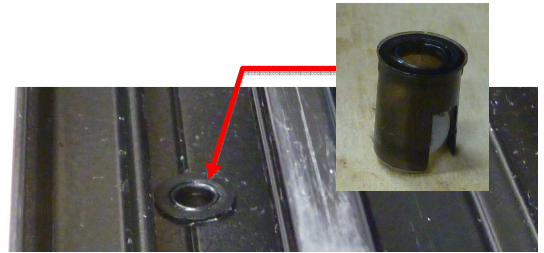
- One of the houses investigated had windows with ball valves in weep holes (Figure 6). The home-owner reported that leakage was minimal.

Figure 6. Window frame with ball valve (inset) in weep hole

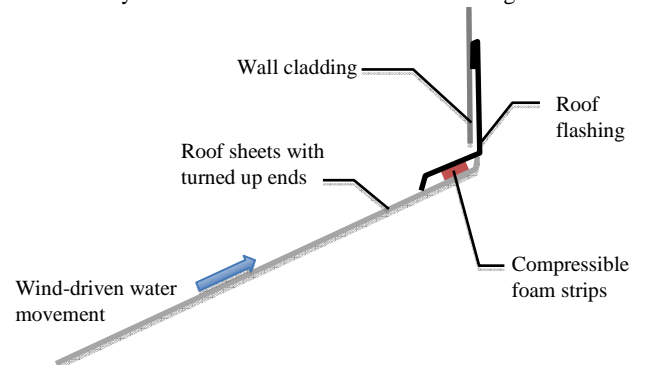
These strips reduced airflow through the gaps under the flashings so that water was not entrained in the air. Where the foam strips had not been well secured, the differential pressure forced them into the cavity and allowed water to enter the building.

Figure 7. Compressible foam strip under apron flashing between second storey wall and first storey roof
