# Lessons in Resilience from Tropical Cyclone Ilsa

Geoffrey N. Boughton<sup>1</sup>, David J. Henderson<sup>1</sup>, Lucas van Woensel<sup>2</sup> and Debbie J. Falck<sup>1,\*</sup>

<sup>1</sup>Cyclone Testing Station, College of Science, Technology and Engineering, James Cook University, Townsville, Qld, 4811

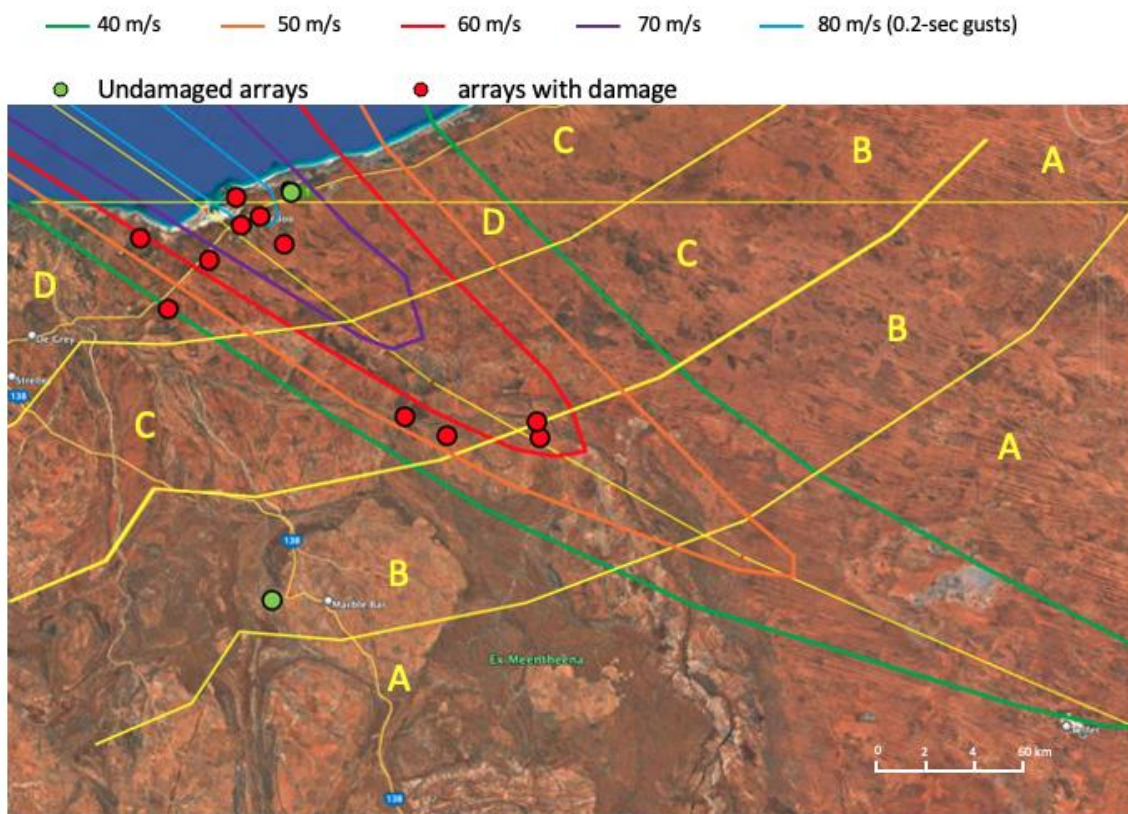
Figure 1. Wind field in TC Ilsa and the location of the solar panel installations studied.

The resulting wind field is shown in Figure 1, which also shows the locations of solar panels studied during the investigation. Green dots indicate the location of undamaged installations and red dots the location of damaged installations. The yellow lines separate the wind regions in 2023 with the letters indicating the wind regions assigned in AS/NZS 1170.2:2021 (Standards Australia, 2021). Coloured contours show the peak gust (0.2 second duration – compatible with AS/NZS 1170.2) wind speeds.

Figure 1 shows only two installations that were undamaged in the inspection area. One near Marble Bar, was well outside the zone of maximum winds and experienced a peak gust of around 25 m/s. The other was a ground mounted array near Pardoo that experienced peak gusts around 70 m/s. The good performance of this array indicated that it is possible to design ground-mounted systems to resist severe tropical cyclones.

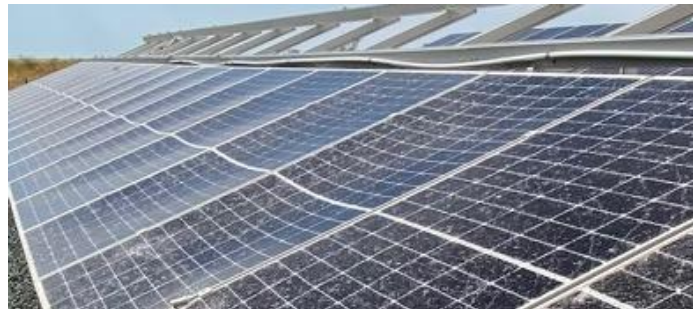
Figure 2 shows a ground-mounted array that illustrates the two modes of failure explained below.

**Figure 2. Examples of failure of ground-mounted solar panels**

The lower panels in Figure 2 failed by bending of the panel as a plate. In this case, the wind had been on the face of the panel, but in other cases, the wind had been on the underside of the panel and had caused upward bending. Many panels that had flexed upwards moved far enough to disengage from the panel chassis and the panel was completely lost.

The upper panels in Figure 2 failed by detachment of the clips or brackets that held the panels to the rails. In some cases, the clips had broken, and in others, they had moved sufficiently to release the panels. Where the clips were bolted to the aluminium chassis of the panel, the bolts tore the chassis, which caused detachment.

Most ground-mounted solar panels in the study area did not perform well and attention needs to be given to wind actions on the inclined systems, particularly differential pressures across the panels and the net forces on anchorage points.

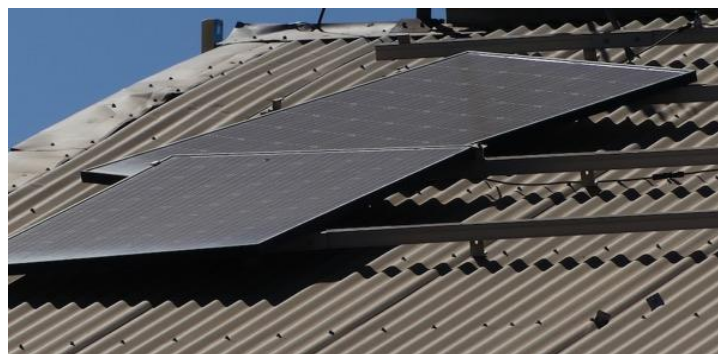
**Figure 3. Failure of clips on roof-mounted PV arrays**

Figure 3 shows detachment of panels clipped to rails parallel to the roof.

These failures were caused by either overloading of the clips or by movement of the clips under repeated cyclic loads on the panels typical of long-duration cyclonic events.

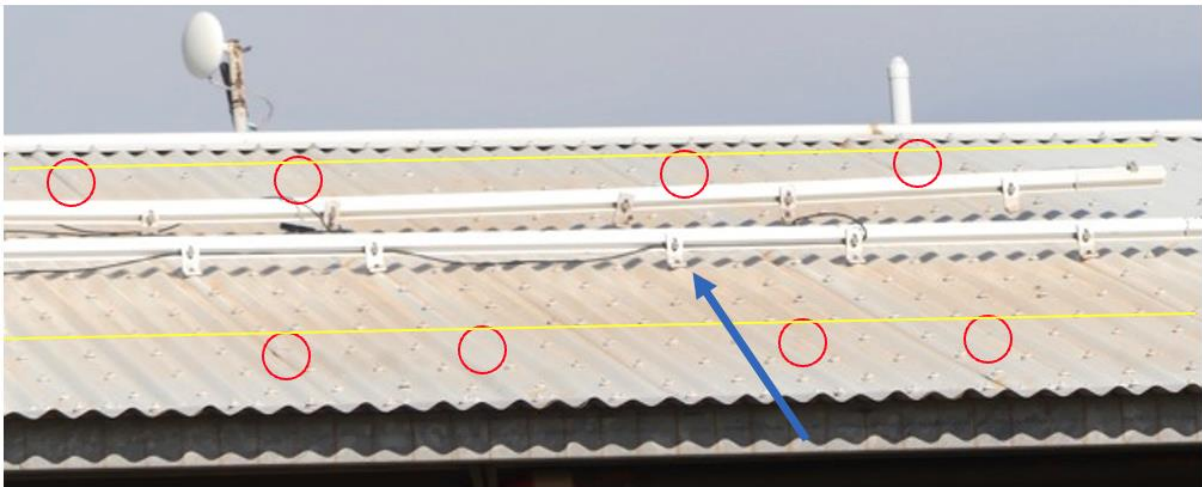
In some cases, the brackets holding down the rails overloaded the roofing screws into the batten – the rails and the panels they supported were lost. Figure 4 shows a roof with missing rails (indicated by the yellow lines) and missing roofing screws (highlighted by red circles).

**Figure 4. Loss of roofing screws at brackets that held the PV rails**

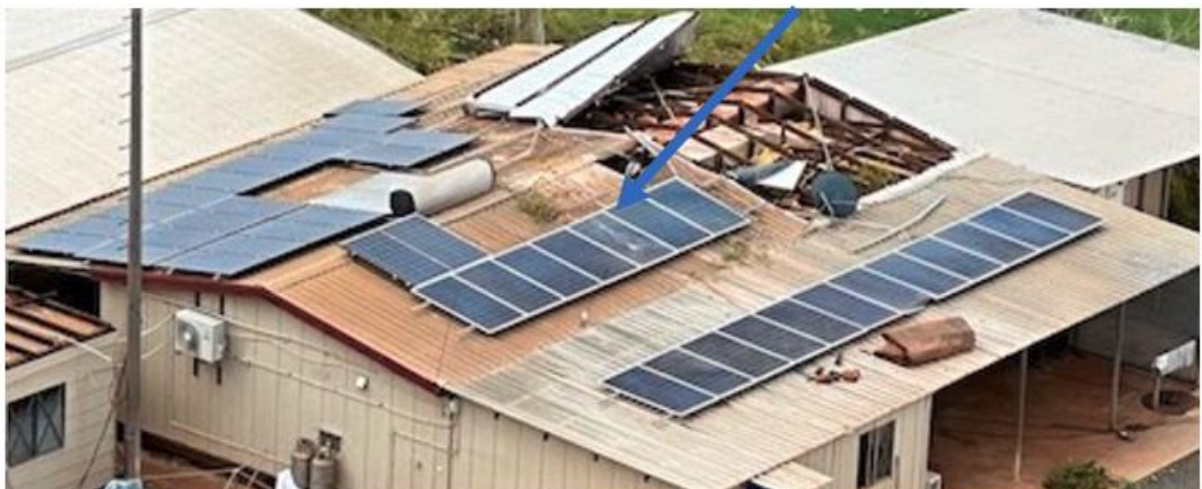
Figure 5 shows a building with solar panels where the batten fixings under the panels had failed. Two identical buildings built at the same time and in the same orientation as the damaged building did not have solar panels installed. There was no damage to the battens, batten fixings or roof of the buildings that did not have the solar panels installed.

**Figure 5. Damage to batten fixings under roof-mounted solar panels in TC Ilsa WA 2023**

- Inadequate wind rating – often where dongas (transportable buildings) had been brought into a high wind area from a low wind area.
- Loads from roof-mounted solar panels as shown in Figure 5, or impact from solar panels as wind-borne debris.
- Failure of attachments such as verandas or awnings.
- Internal pressures following failure of doors or windows, or in the case of open sheds, the blockage by the contents of the shed generated internal pressure in an otherwise open shed.
- Deterioration of structural elements such as tie-down provisions

Some attachments to the roof may attract additional wind actions that have not been anticipated by the building designer. These attachments may include air-conditioner condensers, satellite dishes, vents or flues and solar panels. Where these elements are fitted to an existing roof, the current structure must be checked for the additional wind loads attracted by the attachments. In many cases, local strengthening of part of the roof is required to ensure sufficient wind resistance of the structure.
