A Coastal Microburst Wind Damage Survey and Observations

M.J. Glanville¹ and N.A. Moir²

ABSTRACT

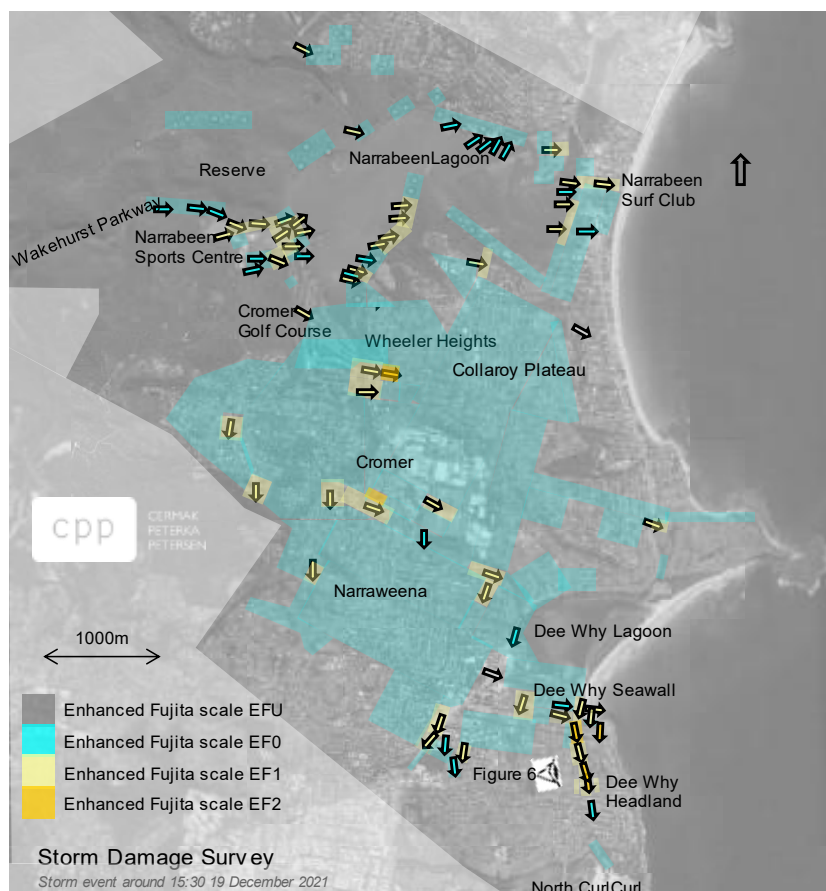
Figure 3. Estimated EF-scale damage ratings assigned to surveyed buildings and natural environment.

Figure 3 maps all observed damage rated against the EF-scale. Damage generally being assigned an EF0 or EF1 rating, and some isolated EF2 damage. Most EF0 damage evidence was medium to large branches snapped off large trees and EF1 small to large trees snapped or uprooted; the fallen trunks providing an indication of wind direction. Several roofs were blown from homes and apartments indicative of EF2 damage, e.g., Figure 5.

Author¹ witnessed the most severe property damage over the survey area within 24 hours of the storm and assigned the EF ratings consistently with previous surveys of other wind storm damage, e.g., Krupar, Mason & Glanville (2016). Some areas such as the Cromer golf course were not inspected until after considerable clean-up had occurred and if the damage was not witnessed first-hand or a via reliable photo/videos then it was not marked in Figure 3 with a direction arrow. Markers are included for each geo marked survey photo including EFU areas with no visible damage.

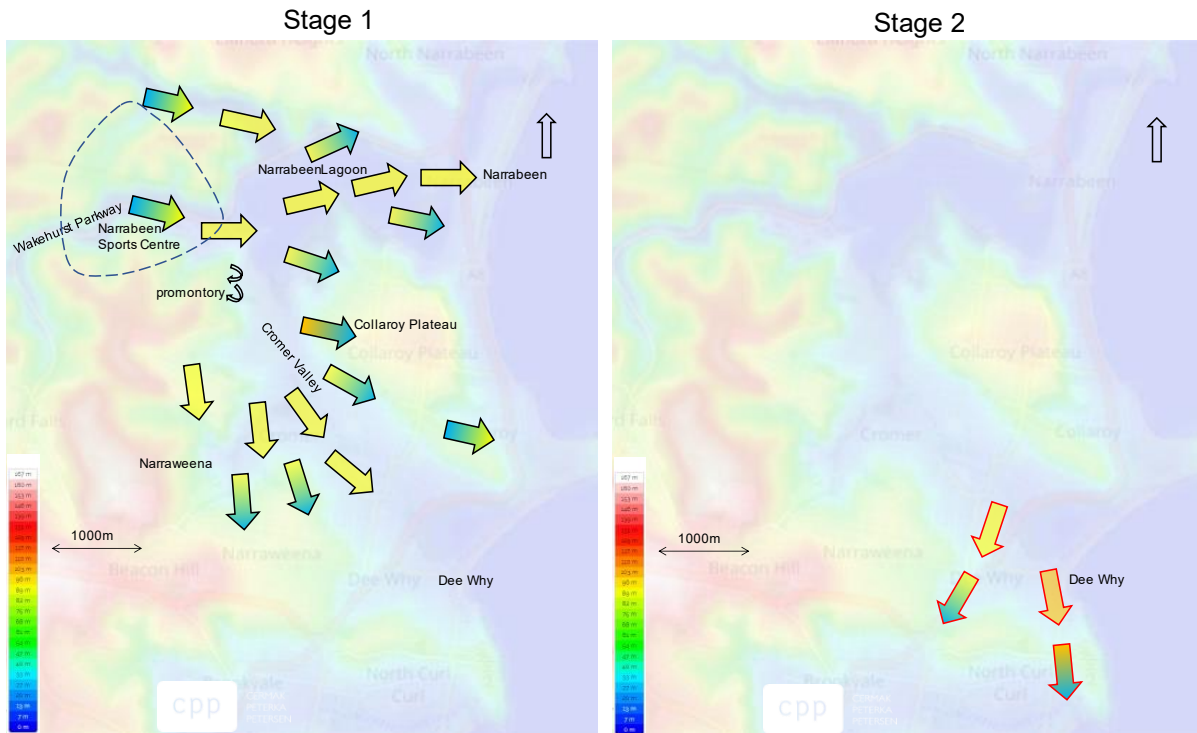
Topographic contours (sea level to 170m) are overlaid in Figure 4 with larger arrows providing an interpretation based on the study observations and photographs above. The initial microburst appears to have occurred with a stagnation point to the west of Narrabeen Lagoon in the reserve and over the Wakehurst Parkway valley, with an approximate initial footprint shown by the broken line.

Terrain was observed to play a primary role in the spread of the outflow. In 'Stage 1' the outflow appears to sink immediately into the Wakehurst Parkway and Narrabeen Sports Centre valley with the cold heavy high velocity flow staying below about 70m terrain height as evidenced by tree damage; buoyancy appearing to govern the outflow pattern. The outflow then appears to split in two directions; one path continuing over Narrabeen Lagoon and the other into the Cromer valley toward Dee Why.

Figure 4: Flow interpretation from photos and survey damage overlaid on topographic contours.

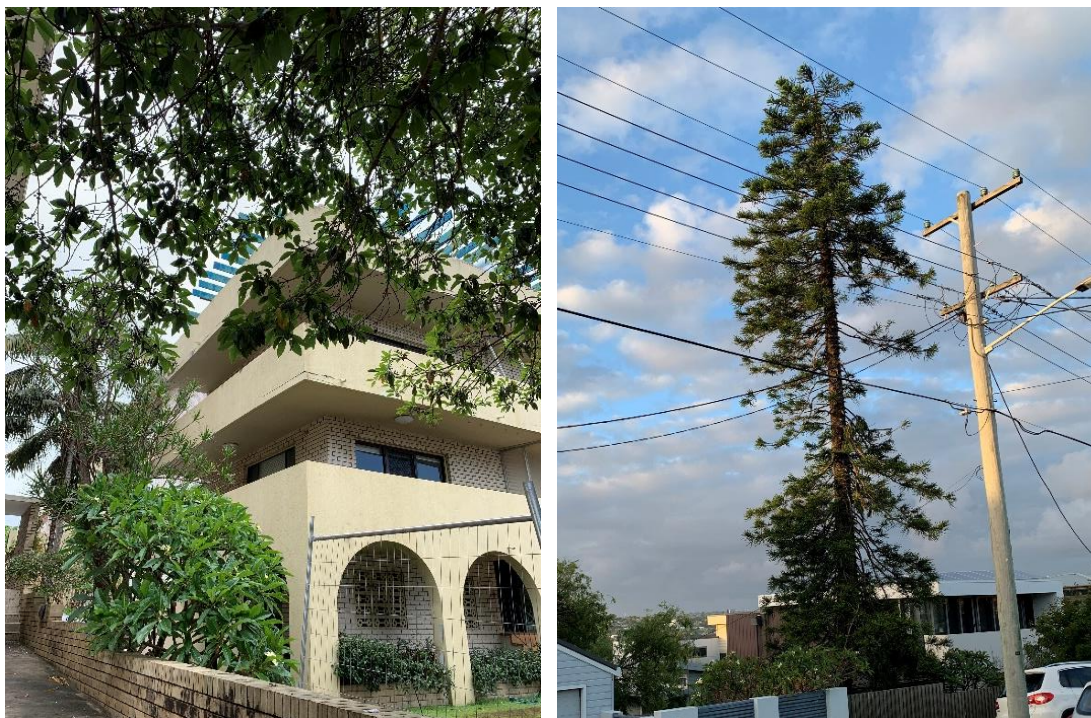
Part of the initial Dee Why outflow is channeled between buildings lining The Strand to the south before lifting the roof from a 4-storey unit block on Pacific Parade as captured in video footage contained in the Northern Beaches Advocate (2021). Analysis of video footage approximates roof height wind speed in the order 40-50 m/s yet undisturbed gardens at ground level of the same building are seen in Figure 5. This suggests a localised jet nature to the outflow with minimal turbulence mixing at ground level. Roof debris was carried directly downstream with the rain laden outflow in a SSE direction causing some projectile impact damage to property.

Figure 5: Unit block on Pacific Pde lost its roof yet suffered no damage at ground level (L). Branches snapped from the central 1/3 of a Norfolk Island Pine (R).

High velocity flow continues over the headland, causing similar roof damage to a 2-storey home on Tasman Street near the hill crest. A relatively narrow arm of damage swathe over the headland perhaps a couple of house blocks wide was found, seemingly with jet flow skimming over the building rooftops where it could gain momentum. The greatest building damage was observed to homes protruding into the jet stream.

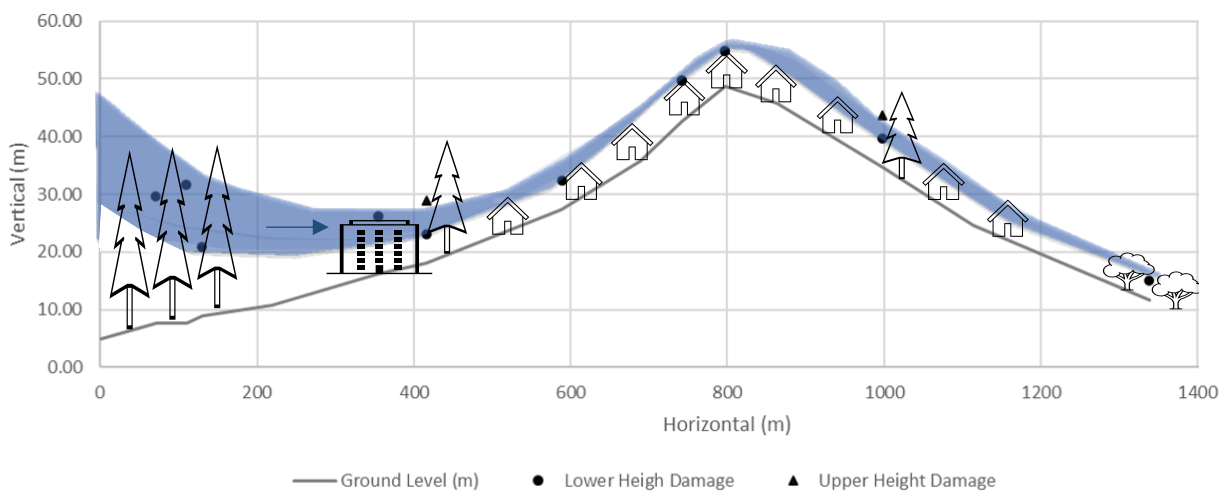
A vertical profile of observed damage over the Dee Why headland is mapped indicatively in Figure 6 based on the damage survey (note profile viewing angle in Figure 3). Branches snapped from several Norfolk Island Pine species provided in some cases a lower and upper bound to observed damage and supported a jet velocity profile hypothesis, Figure 5. The thin ribbon of outflow continued over the Dee Why headland then sunk downhill toward North Curl Curl Beach. Similar outflow characteristics can be observed in other media video footage of the event, e.g. Ralph (2021).

Figure 6: Estimated vertical outflow profile over the Dee Why headland based on damage survey.
