## ADVANCEMENTS IN THE DESIGN OF WINDOW GLASS AGAINST WIND ACTION

Joseph E. Minor, P.E.<sup>1</sup>Introduction

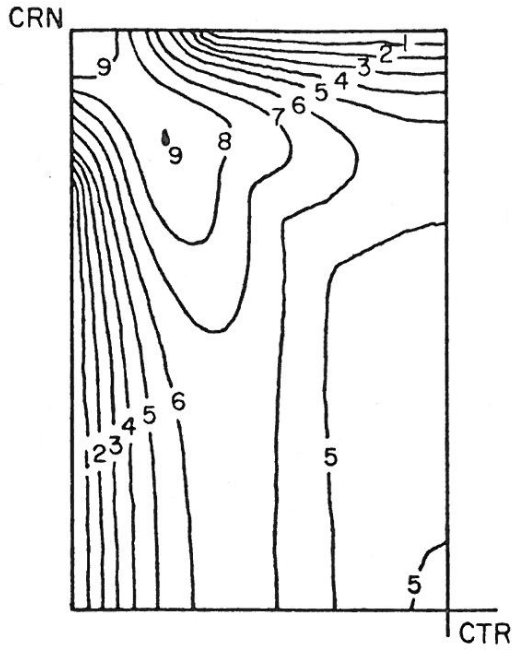
a. Stresses in ksi by Theory [11]

In 1979, Vallabhan and Wang published a stress analysis for thin glass plates which employs a method of finite differences [10]. The numerical analysis is very efficient with computer time, has been verified experimentally (Ref. Fig. 1), and is available as an annotated computer program [11]. Refinements of this program [12] provide for the analysis of thin glass plates on elastic supports representing gaskets or sealants. Design charts based upon these stress analyses have not appeared, although such charts could be generated.

FIGURE 1. COMPARISON OF STRESSES IN 60 x 96 x 0.225 IN. (1.52 x 2.44 x .006 m) GLASS PLATE LATERALLY LOADED TO 0.70 PSI (4.83 kPa)

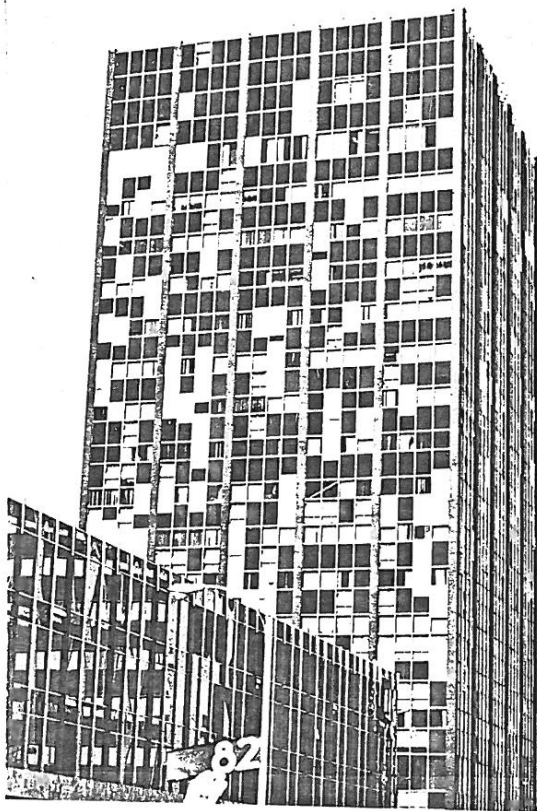
A pattern of window glass failure in windstorms beginning in 1970 and culminating with a dramatic event in Houston, Texas in August 1983 establishes windborne debris as a factor in glass breakage. Glass in the Guaranty Bank Building in Corpus Christi, Texas was damaged by windborne debris in 1970 and again in 1980 (Ref. Fig. 2). Windborne debris was reported to be a factor in window glass and cladding damage in Cyclone Tracy (1974), Hurricane Frederic

a. Following Hurricane Celia (1970)

FIGURE 2. WINDOW GLASS DAMAGE TO GUARANTY BANK PLAZA, CORPUS CHRISTI, TEXAS (USA) CAUSED IN PART BY WINDBORNE DEBRIS

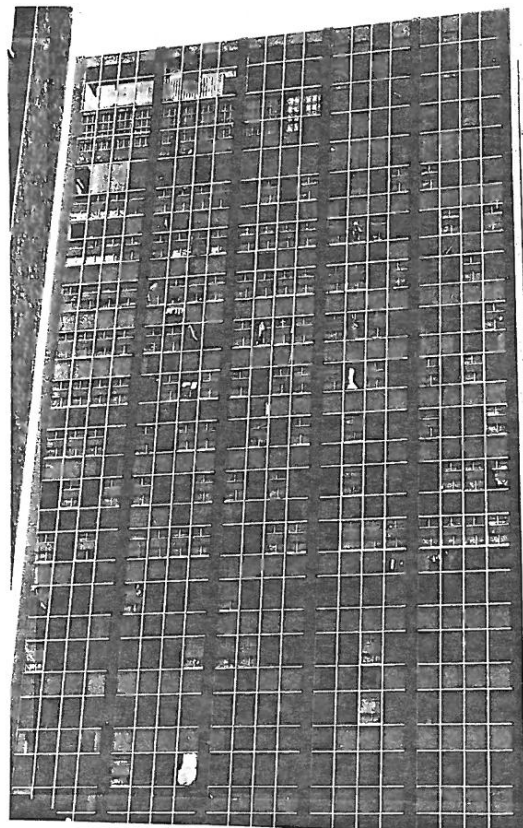
b. Following Hurricane Allen (1980)

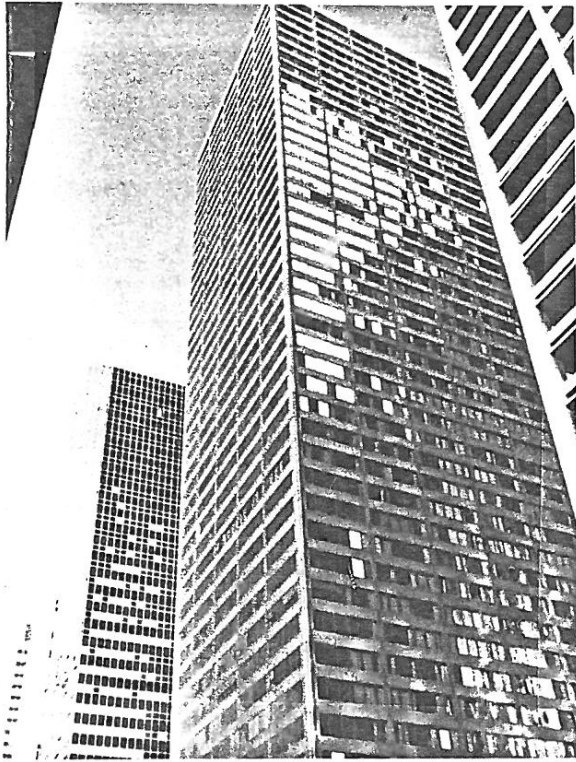
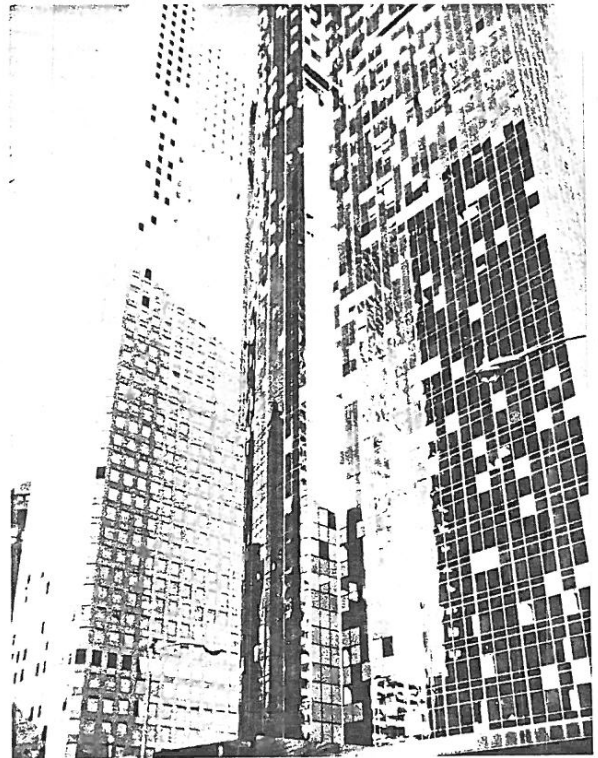
FIGURE 3. WINDOW GLASS DAMAGE IN DOWNTOWN HOUSTON, TEXAS (USA) CAUSED BY HURRICANE ALICIA, AUGUST 18, 1983

a. 100 Milam Building (foreground) and Entex Building

b. Allied Bank Building (foreground) and Interfirst Bank Building

Many high-rise buildings in Houston, Texas experienced glass damage and glass breakage during the passage of Hurricane Alicia on August 18, 1983. The most dramatic glass damage and breakage occurred in a relatively small area in the city center (Ref. Fig. 3). Attention which was focused on this small area overshadowed window glass damage in other high-rise buildings which occurred throughout the city.

Media reports attributed most of the window glass damage in the city center to windborne debris, principally roof gravel, but including debris from signs, roof appurtenances, and architectural facia. Wind engineers and curtain wall authorities who participated in a special session on Hurricane Alicia at the October 1983 National ASCE Meeting [18] attributed the glass damage to five factors: (1) windborne debris, (2) wind pressure, (3) out-of-plane deflections in glass support systems, (4) in-plane "racking" of glass support systems, and (5) improper installation.

Several downtown buildings (ranging up to 77 floors in height) were glazed with fully tempered (toughened) glass. When some of these units broke, the resulting small particles were injected into the airstream, contributing missiles which broke or damaged additional units. News media photographers and eyewitnesses reported glass plates flying intact, suggesting that at least some units were removed from buildings by wind induced pressures. Post storm

inspections revealed surface damage (pits, scratches) to a high percentage of unbroken units. This damage was found on all sides of several buildings and on floor levels above adjacent rooftops, indicating that debris impacts were not limited to line-of-sight trajectories from debris sources. Post storm inspections also revealed that some window units had "walked" within their frames, leaving one edge unsupported.

The performance of glazing in windstorms, with particular reference to hurricanes, suggests that windborne debris is a factor that must be addressed in design. In circumstances where windborne debris constitutes a hazard, design processes should take this factor into account.
