The Australasian Wind Engineer

Technical Note - Kurnell Tornado and Thunderstorm Outflow Events: 16 December 2015

Contributors: Richard J. Krupar III¹, Matthew S. Mason¹, Matthew J. Glanville²

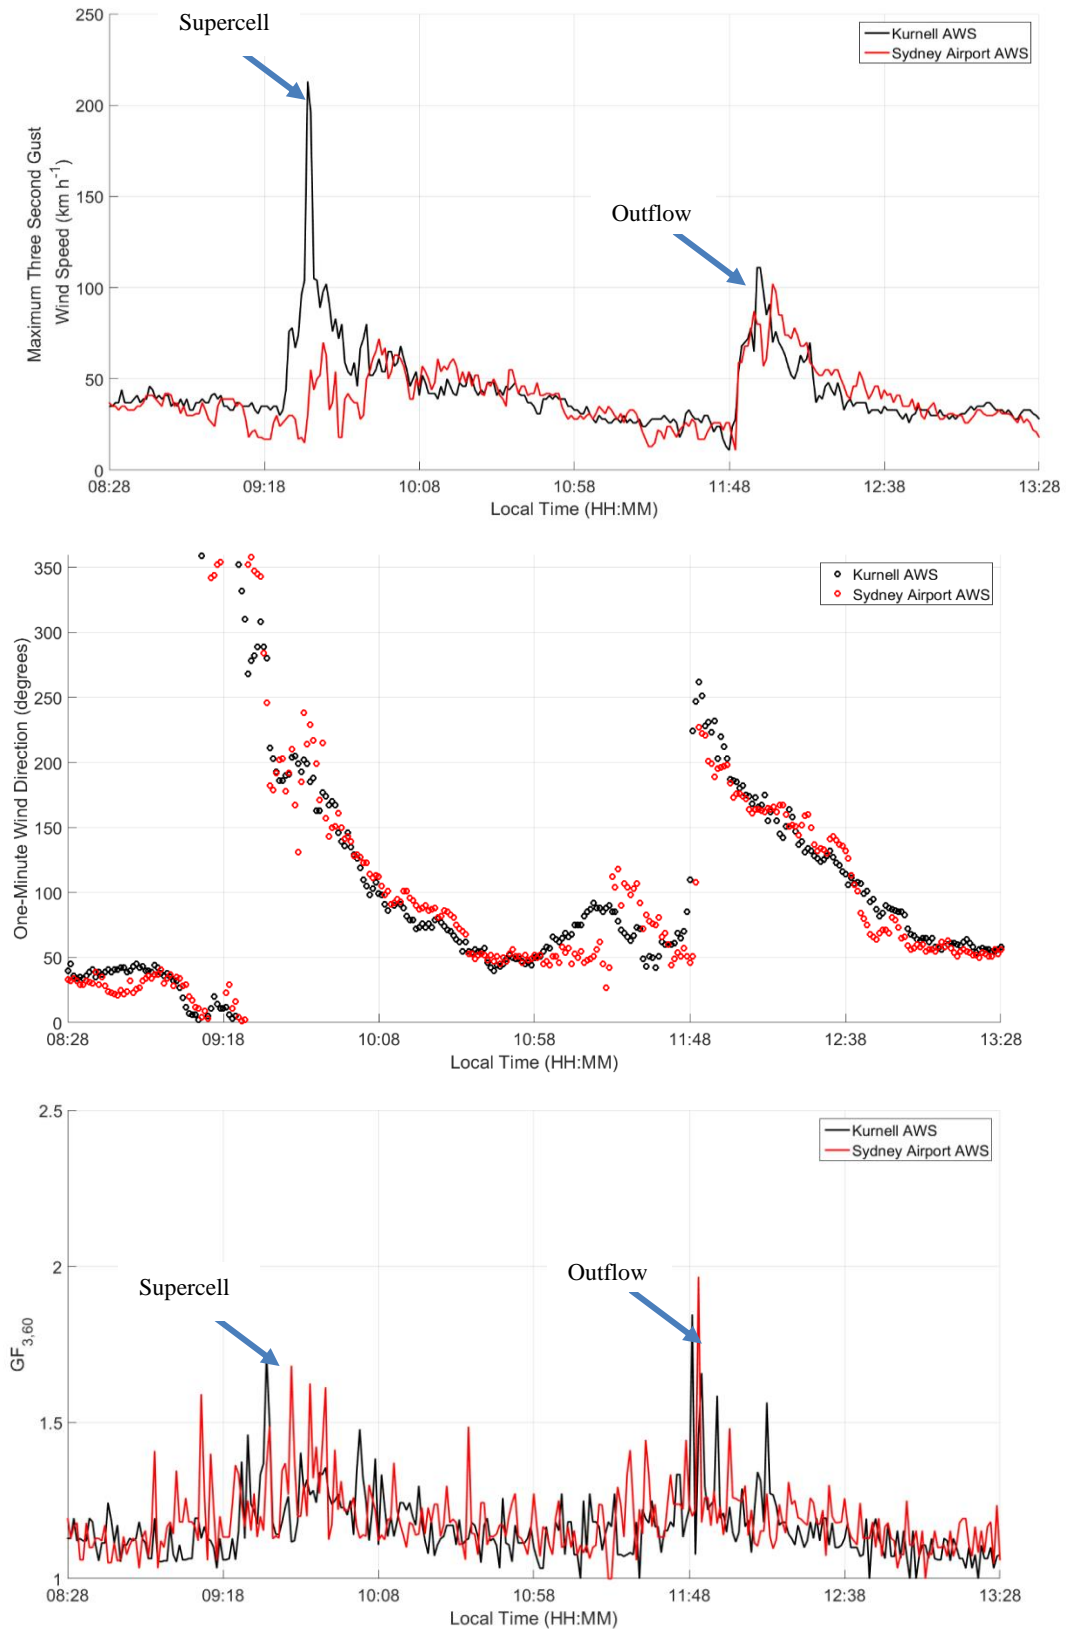
Figure 2. Kurnell (solid black line) and Sydney Airport (solid red line) AWS station maximum three-second gust wind speed time histories (upper), wind direction (middle) and gust factor ($G_{3,60}$) (lower), during the passage of a tornadic supercell and thunderstorm outflow.

As the tornadic supercell continued moving north-northeast, the BoM AWS located on a jetty north of Kurnell recorded a maximum three-second gust of 213 km h⁻¹ at 10 m above ground level (Figure 2, upper). This was the strongest wind gust ever recorded by a BoM AWS station in NSW. The gust factor ($G_{3,60}$, defined as the maximum three-second gust divided by the one-minute average wind speed) was 1.72 at the time of the maximum gust (Figure 2, lower). Inspecting the wind direction plot, Figure 2 middle, a sudden shift in the one-minute mean wind direction from 280 degrees to 200 degrees is shown in the few minutes around the peak. Winds continue to back from a southerly direction for the next ten minutes before gradually shifting through to the northeast over the next hour.

Inspecting then the Sydney Airport AWS, located 7 km to the north-northwest of the Kurnell AWS, a maximum gust of only 72 km h⁻¹ at 10 m above ground level was recorded. The associated gust factor at the time was 1.49. Interestingly, the pattern of gust wind speed time histories, albeit lagged in time, is quite similar when the tornadic supercell passed over both AWS stations. The wind direction also followed a similar sudden shift to that measured at Kurnell, but the change was from an almost northerly direction through to south.

Later in the morning, around 11:18 am, a convective thunderstorm complex developed east of Stanwell Park. The complex of thunderstorms followed a similar track to the tornadic supercell and travelled northward along the NSW coastline towards Kurnell. An outflow radar signature was noted in the 0.9o elevation PPI beginning at 11:25 and propagated over the Kurnell AWS around 11:49 (Figure 2). A maximum three-second gust of 111 km h⁻¹ was recorded by the Kurnell AWS during the passage of the outflow and the gust factor was $G_{3,60} = 1.59$ (Figure 2, lower).

At the same time the Sydney Airport AWS measured a maximum three-second gust of 102 km h⁻¹ and gust factor of 1.97. It was surprising to see the gust factor measured by the Sydney Airport AWS was larger than the Kurnell AWS gust factors computed during the passage of both the tornadic supercell and thunderstorm outflow. This second wind event displayed a more common, larger scale convective outflow signature than the first, and gusts near to the magnitudes recorded at Kurnell and Sydney Airport were measured at several stations across the Sydney basin. A sudden wind direction shift from northeasterly inflow to southwesterly outflow was recorded almost simultaneously at both stations, along with a 4-5oC drop in temperature.

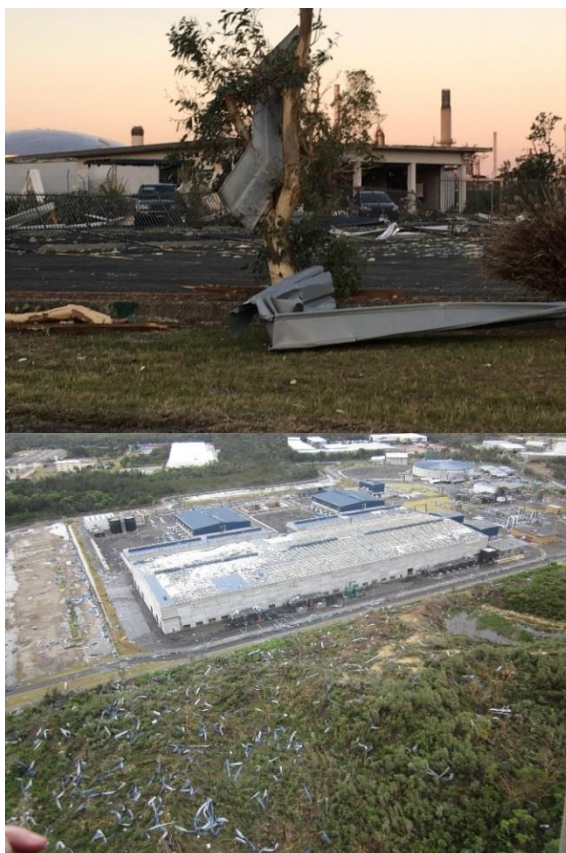
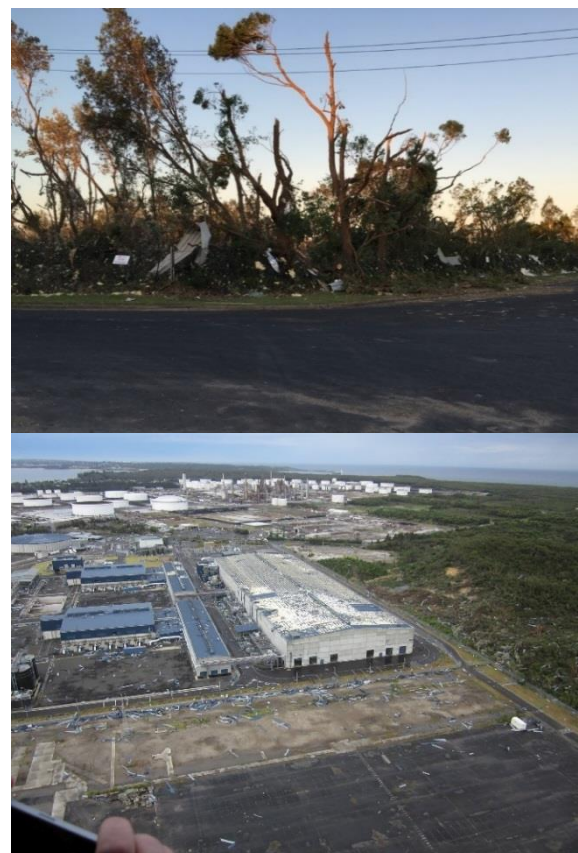
Figure 4. Examples of the debris from the desalination plant and surrounding buildings. The upper two images are from Sir Joseph Banks Drive and the lower two images were captured by the Westpac Lifesaver Rescue Helicopter over the desalination plant.

Continuing north, the desalination plant lost metal deck sheeting over much of its roof plan with sheeting and insulation found deposited hundreds of metres from the plant. Much of Sir Joseph Banks Drive was littered with debris from this and other buildings (Figure 4). Distinct signs of multidirectional flow can be seen in the lower two images of Figure 4, where roof sheeting is seen deposited on all sides of the plant building. A clear swathe of sheeting is shown to the south (lower left) of the plant—this is the opposite direction to the movement of the storm—with sheeting also seen to be blown hard-up against the southerly side of the fence in the lower right image. Industrial units in the direct path suffered façade breaches including broken windows and lifted roof sheeting. On Chisholm Road a lorry was blown over onto an adjacent and thankfully empty parked car (Figure 5). As the tornado continued northwards crossing Captain Cook Drive it passed over roadside high voltage transmission lines, but no damage was evident to these structures. Similarly, no obvious damage could be sighted to the refinery east of Captain Cook Drive.

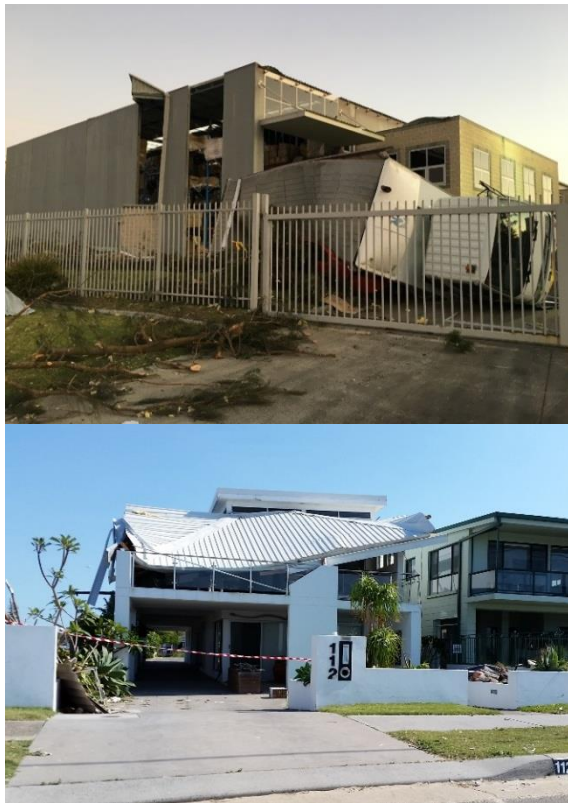
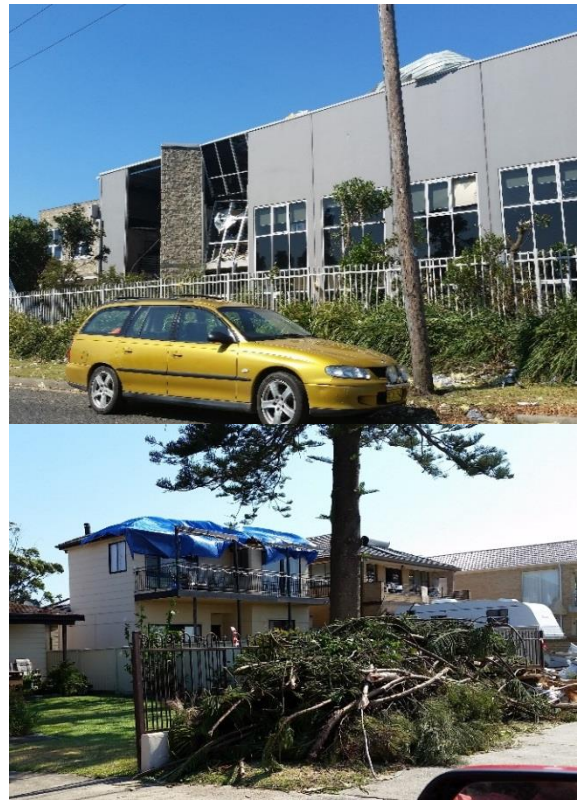
Figure 5. Examples of damage to industrial buildings (upper two) and residential buildings (lower two).

The tornado passed directly over the residential township of Kurnell northward to Botany Bay. Inspecting damage in the residential zone was reminiscent of surveying water spout damage in Lennox Head 2010 in that damage was confined to a finite width outside of which little permanent damage could be observed. (Figure 5). Roof damage was common to buildings in the damage swathe, with lifted roof sheeting, missing tiles and lifted solar panels observed. Temporary structures were also displaced (e.g. garden sheds, awnings a trampoline and fallen trees). An interesting video of the swathe captured by a drone flight (<http://www.dailymail.co.uk/news/article-3363439/Drone-footage-shows-damage-Kurnell-tornado.html>) shows the extent of damage through the township.
