## Cyclone Yasi Storm Surge

**George R. Walker**

### Abstract

Cyclone Yasi produced one of the largest storm surges to impact Queensland since European settlement. Fortunately it occurred close to low tide but it caused significant damage at Tully Heads. The paper describes the main features of the storm surge, the resulting pattern of damage, and the implications for the structural design of buildings. It is concluded that buildings can be designed in storm surge prone areas which could provide safe havens as an alternative to evacuation, and that design criteria need to be specified for this with the design return period being a critical issue.

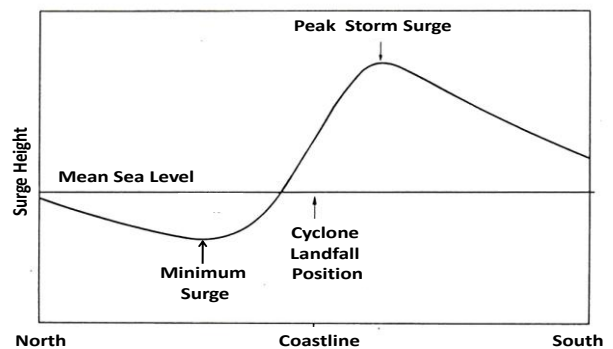
The storm surge accompanying a tropical cyclone is a temporary change in sea-levels produced by the combination of low pressure and strong winds. Well away from the coast the surge is predominantly a mound of water which mirrors the pressure drop, the increase in sea-level being approximately 1 cm for every drop in surface pressure of 1 hPa (Stark, 1980). As this mound of water approaches the coast it is amplified due to frictional effects associated with the shallowing of the water and high wind stresses on the sea surface which push water towards or away from the coast. The storm surge tends to be highest on the edge of the eye where the winds are strongest falling away either side of this. Along the eastern Queensland coastline this would typically result in a profile of storm surge north and south of the eye as shown in Figure 1

Figure 1. Schematic of variation in height of storm surges along the east coast of Queensland

the peak storm surge can vary greatly, and the variation along a coastline can also vary greatly from the smooth curve shown in Figure 1. However mathematical modelling of storm surge development taking these factors into account is a relatively well established technique, and has become the basis of most forecasting of storm surge heights.

Comparison with Figure 1 shows no evidence of the expected negative surge north of the track. This may be due to the dominance of the 'inverted barometer effect' from a relatively low central pressure and off-shore wind speeds less than typical due to the topography of the area. The jump in levels between Townsville and Cape Ferguson probably demonstrates the effect of different local features, with Townsville facing north within Cleveland Bay with Cape Cleveland to the east and Magnetic Island to the north, and Cape Ferguson being on the southern side of the Cape Cleveland peninsula and facing south.

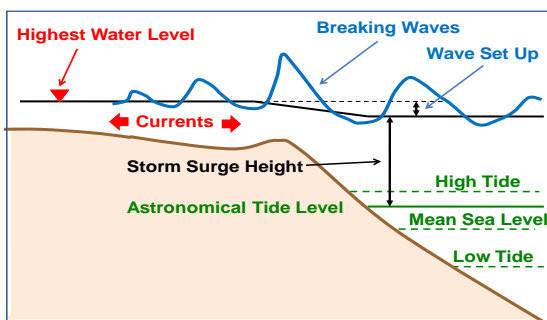
The level of impact of the storm surge on coastal buildings and other structures depends on the combination of storm surge height, the normal astronomical tide levels on which it is superimposed, and the associated wave action, which increases the actual water level at the coastline due to wave set up. This combination is depicted schematically in Figure 2.

Figure 2. Schematic of Combination of Storm Surge, Tide and Waves at Coastline

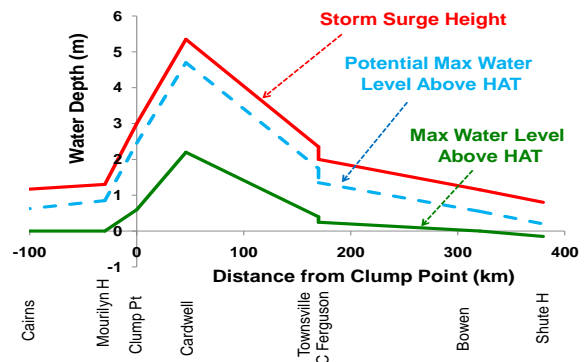
Figure 3 shows the measured storm surge heights in Yasi at different locations along the east coast of Queensland relative to Clump Point which approximately corresponds to where the centre of the eye is believed to have crossed the coast. Also shown is the actual maximum sea level relative to Highest Astronomical Tide (HAT) which gives a better indication of the actual sea level at any locality, and the potential maximum sea level relative to HAT if the storm surge had coincided with the maximum adjacent high tide, which in this case was the following high tide around 8 hours later.

Figure 3. Storm surge profile along coast

Contrary to what might have been expected from Figure 3 the maximum structural damage from the storm surge occurred at Tully Heads where the storm surge would probably have been between 3 and 4 metres, with highest water levels probably of the order of a metre or so above HAT unless there were local features which amplified it. This storm surge height and highest water level above HAT were considerably below the corresponding values for Cardwell. Furthermore the corresponding values at South Mission Beach and Mission Beach would probably not have been much less than at Tully Heads. Yet at Tully Heads almost all the houses alongside the road parallel and closest to the beach suffered major damage from

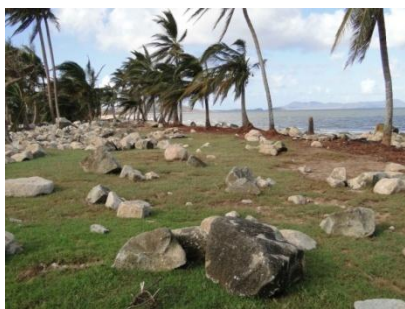
The reason for this difference appeared to be the height of the ground floor level relative to HAT. Figures 5 and 6 contrast the coastal situation at Tully Heads and at Port Hinchinbrook in the Cardwell area. At Tully Heads the back lawn shown is hardly above beach level, the rocks scattered about the lawn apparently coming from a destroyed seawall which was intended to protect the property. At Port Hinchinbrook the houses are on top of a bank significantly above beach level, and this is the same in Cardwell itself. As a consequence at Tully Heads water surged through properties up to a depth of over a metre on the seaward side of the street and up to 0.8 m on the landward side of the street, cleaning out the ground floor of 2 storey houses as shown in Figure 7. Single storey houses were also cleaned out if not totally washed away as shown in Figure 8. In the Mission Beach and Cardwell areas maximum levels of inundation reported were of the order of 200 mm with minimal structural damage and only moderate damage to contents in general as shown in Figure 9.

Figure 5. Back Lawn at Tully Heads

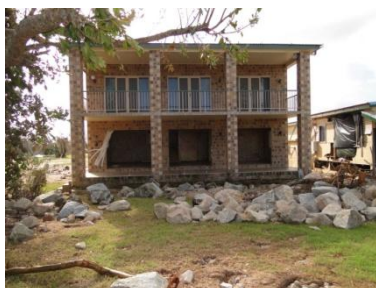
Figure 7. 2 Storey house on seaward side of road at Tully Heads. (Same property as Figure 6)

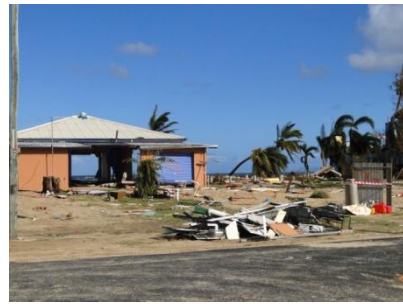
Figure 8. Single storey houses at Tully Heads - one washed away

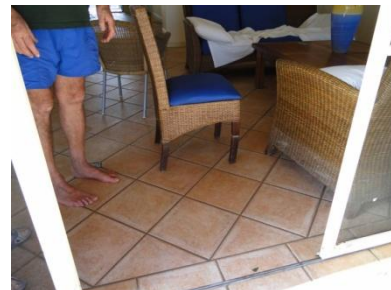
Figure 9. Marks on chair leg and cane settee show depth of storm surge inundation at Port Hinchinbrook

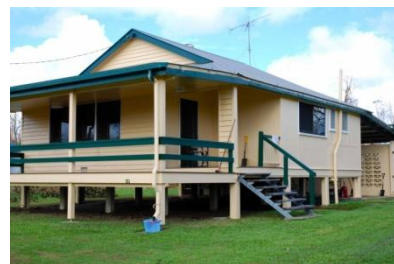
On the positive side at Tully Heads, the upper floor and roof of most 2 storey homes suffered little or no structural damage with loss of some guttering the main loss, and one house appeared to have escaped the destruction altogether as shown in Figure 10. Significantly this latter house was on stumps which allowed the surge to go under the house without putting significant forces on it.

Figure 10. Undamaged house at Tully Heads close to sea (Photo G.N. Boughton)

- The level of the ground floor of a building relative to the Highest Astronomical Tide (HAT) level is important
- Buildings can survive in storm surge locations if the ground floor is above the maximum water level experienced and the substructure is designed to allow the water to flow largely unimpeded beneath – although possible scour needs to be taken into account
