## A survey of wind and storm surge damage following Tropical Cyclone Yasi

### Abstract

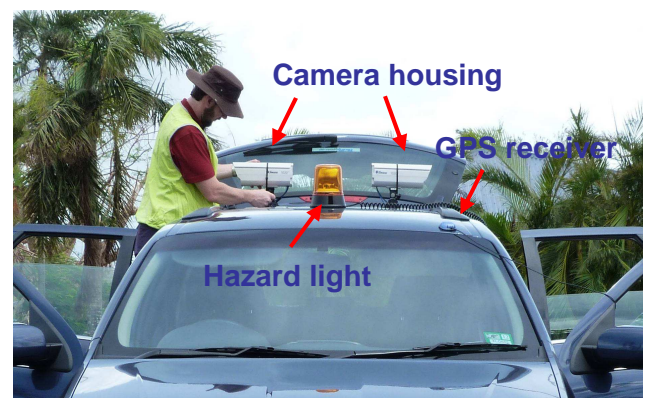
Figure 1. The RICS system mounted on a car. Images from the two cameras and positional data from the GPS receiver are automatically recorded on a laptop computer within the vehicle.

To ensure that data on overall storm surge damage was collected quickly and in view of the vagaries of tropical weather and speed of cleanup GA's Rapid Inventory Collection System (RICS) was deployed during the first trip to photograph all buildings affected within the storm surge area. RICS is a vehicle borne camera system developed by GA that takes geo-located images from a moving vehicle and is available as open source software; Habili et al (2010). The equipment is shown in figure 1. Images taken by RICS are automatically attached to survey database entries by post-survey processing that selects the nearest RICS image to each building location.

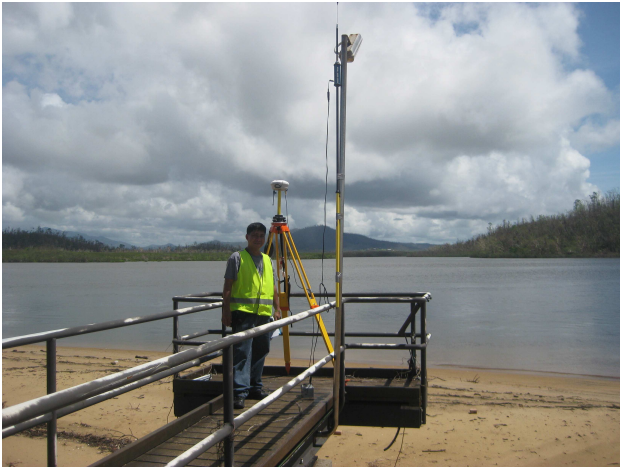
Figure 2. RTK survey equipment positioned over a permanent survey mark.

Data on the extent and depth of storm surge inundation were obtained by a Real Time Kinematic (RTK) survey conducted by NIWA personnel during the second trip. Height and positional consistency was achieved by using Queensland Government Department of Environment and Resource Management permanent survey marks as control points. An example of the equipment is shown in figure 2.

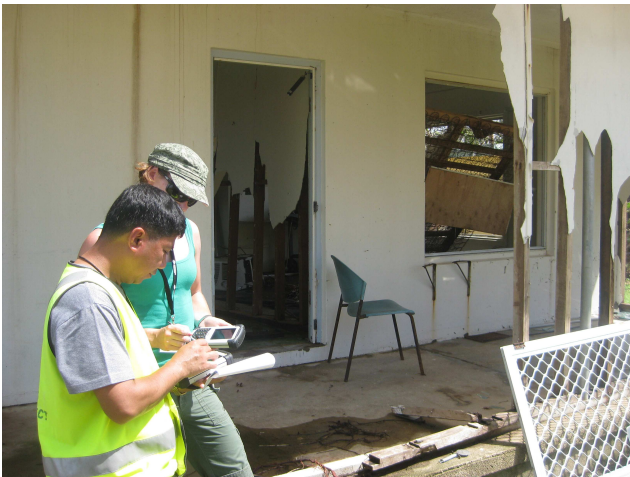
Figure 3. Survey team recording data at a storm surge damaged house. Usually surveyors worked singly however when inexperienced surveyors were introduced to the equipment they were paired with an experienced surveyor.

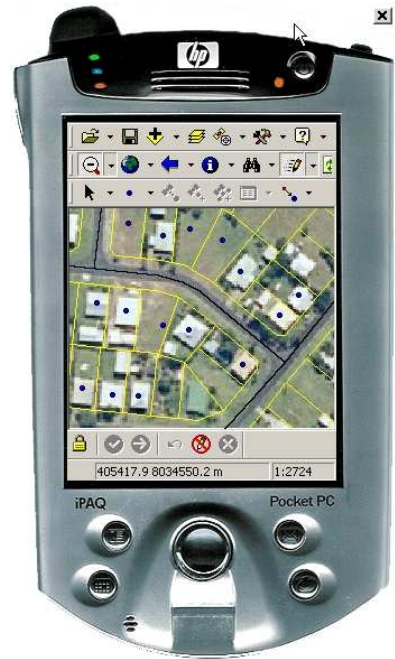
Figure 4. Image of PDA unit showing background image consisting of aerial photo, cadastral information, street layout and NEXIS points.

Recording data began with the surveyor identifying the relevant building on the PDA screen. The PDA recorded the latitude and longitude of the building, retrieved the street address from the NEXIS database and opened the survey template. Figure 4 is an image of the PDA as normally seen by a surveyor showing a small segment of the survey area. Figure 5 is an image of the PDA with a page of the survey template displayed. Note that most data entry is by selection from drop-down lists to speed data entry and improve consistency of responses between surveyors.

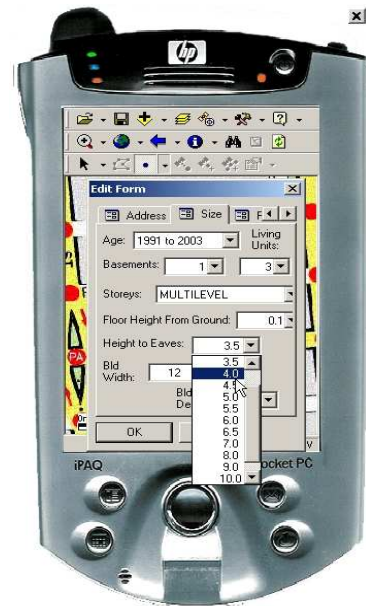
Figure 5. Image of PDA showing a single page of the survey template with the *Height to Eaves* field being entered from a drop-down list.

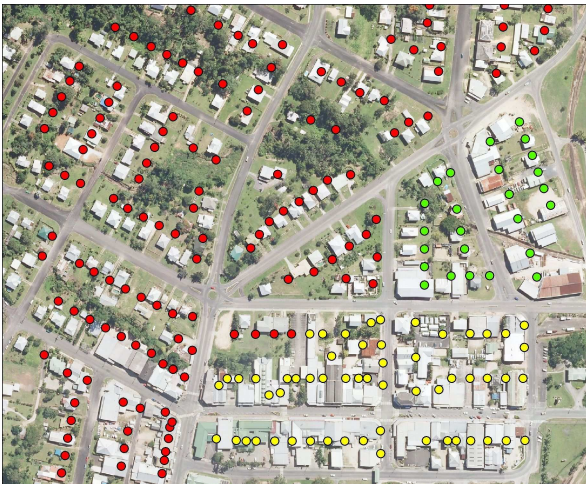
Figure 6. Aerial image of part of Tully showing surveyed buildings. The different colours denote different usages as recorded in the NEXIS database.

The survey covered approximately 1800 buildings of all types in urban areas from Kurrimine Beach to Cardwell. Almost all buildings within urban areas were surveyed with the exception of some houses in Cardwell that were not accessible due to riverine flooding at the time of the third trip. Figure 6 shows an extract of an aerial image of the town of Tully showing surveyed buildings as an example of the coverage of the survey.

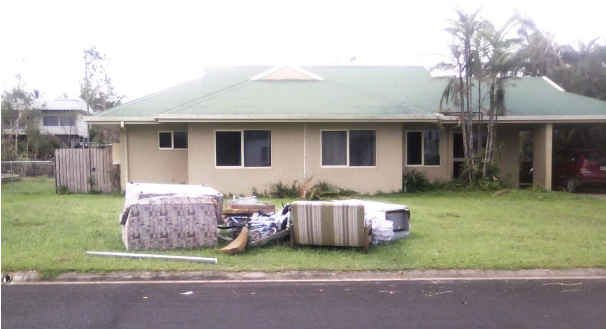
Similarly to previous post-cyclone damage surveys, the assessment of damage due to water ingress proved problematic. The presence of such damage can often be inferred by piles of wet linings and contents on nature strips such as is shown in figure 7. However, the extent of water ingress damage can only be surveyed if access to the building's interior is possible. This is significant as water ingress can yield a damage index up to 0.3 with little or no structural damage.

Figure 7. A house with little exterior damage. The pile of water damaged contents and linings on the nature strip is indicative of significant water ingress damage that would not be detected if the materials and goods had been removed.
