Dynamic Response of Temporary Structures due to Wind Loading T. Pagano¹, K.C.S. Kwok², A. Bishay³, J. Dang³

Abstract

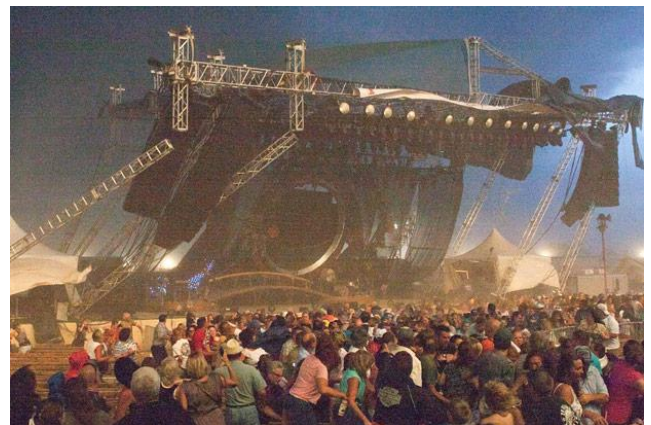
Figure 1. Sugarland Stage Collapse (Callahan, 2012)

Due to the lack of an international standard for the design of temporary stage structures, there have been several instances where temporary stage structures have failed and resulted in injuries and/or deaths during strong wind events. Notable failures include, Sugarland 2011 (Figure 1) (7 fatalities, 40 injured) (Tomasetti, 2012), Big Valley Jamboree 2009 (1 fatality, 40 injured) (Sunga, 2009), Radiohead 2012 (1 fatality, 3 injured) (Mills, 2013).

These failures occurred when the temporary structures have not been built with sufficient strength to withstand unexpected wind forces. Current industry standards do not provide enough information for engineers to determine suitable loads for their design, instead relying on using their own judgment.

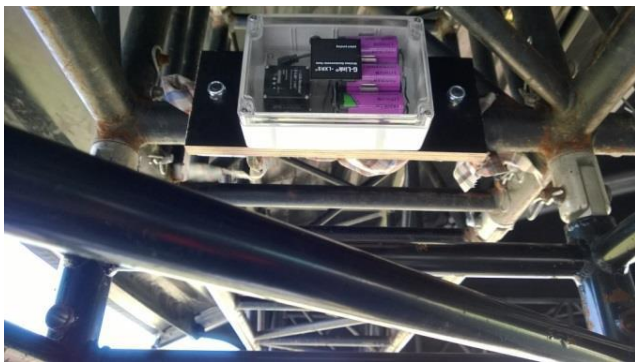
Nodes were attached to the structure using a 17 mm timber base plate in between the casing of the node and corner block member. Half couplers were then used to attach the equipment securely to the test member, as shown in Figure 3. A soft-cloth insulation was placed in between the couplers and the member to help reduce any noise that might be picked up by the nodes. A total of 8 nodes were attached to the structure: 4 connected on the top of the structure (one in each corner) and 4 on the bottom of the structure (one in each corner).

Figure 3. Typical Node Connection

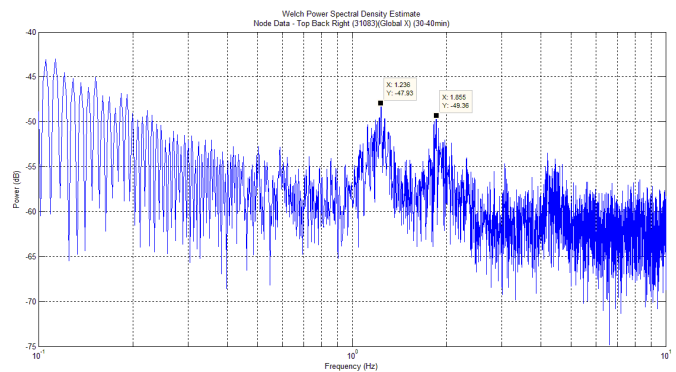
For the Global Z axis, Figure 7 shows 1.699Hz as the first dominate frequency. This was followed by the next peak which was 1.895Hz vs. 1.872Hz from the model. This represents the twisting action of the structure which showed up in both Global Z and Global X Axis results. Figure 8 also shows correlation between the measured results and computed results. It shows a first dominate peak at 1.236Hz, representing the Global X axis, which agrees reasonably well with the numerical analysis of 1.333Hz with a difference of 7.8%. It is noteworthy that the second peak in Figure 8 is almost identical: 1.855Hz vs. 1.872Hz from which has been shown earlier for the twisting action mode.

Figure 8. PSD Result Global X Axis

Numerical Results (Hz)	Tested Results (Hz)
Mode 1	1.333	1.236
Mode 2	1.615	1.699
Mode 3	1.872	1.895, 1.855
