Cyclone Resistant Glazing in Florida, USA – Saving Homes & Businesses

Jennifer Schneider¹, Phillip Davies²

¹Kuraray America Inc. Wilmington, Delaware, USA; e-mail: Jennifer.schneider@kuraray.com

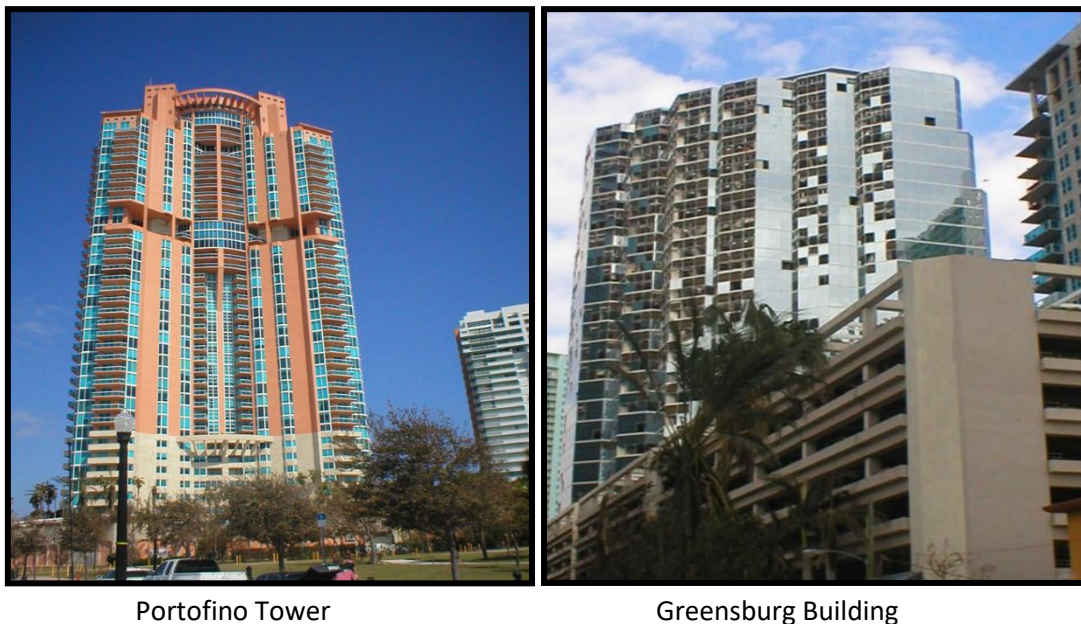
Figure 5: Portofino Tower vs Greenburg Building (Code vs no Code)

The building codes in Florida were put to the test when in 2005 hurricane Wilma hit south Florida causing \$21 billion dollars in damage and killing 21 people. It was of great interest to the Miami-Dade County Building Code Compliance Office to assess damage in the field to determine how effective these codes were in reducing damage to building structures. The findings are summarized in the Post Hurricane Wilma Progress Assessment report. Hurricane Wilma affected many high-rise buildings in the area. Investigation showed that none of the buildings that were built under the new building codes sustained any damage to the glazing system. The buildings that were built before the current codes showed damage to the windows, curtain walls and sliding glass doors. Where the damage occurred, there was interior water damage and rise in internal pressure inside the building causing collateral damage such as roof failures. It was also observed that in areas of tall buildings a channeling of the wind occurred, creating an isolated path of damage. This is an important observation to take into consideration when developing urban areas with tall buildings The Portofino Towers is an example of a building which was constructed to the new criteria. It is a 44-storey building built in 1997 to the Miami- Dade County requirements for High-Velocity Hurricane Zones. After Hurricane Wilma the building including the glazing system did not sustain any significant damage. In comparison, the Greensburg building was not built to the new codes and sustained significant damage with many broken windows – refer to Figure 1.
