Damage to low rise buildings during Tropical Cyclone Yasi

D.J. Henderson¹, G.N. Boughton^{2,3}, J.D. Ginger¹, J.D. Holmes³, G.R. Walker³, C.J. Leitch¹,
 L.R. Somerville¹, U. Frye¹, N.C. Jayasinghe¹, P.Y. Kim¹ and G. Stark¹

¹ Cyclone Testing Station, James Cook University, Townsville

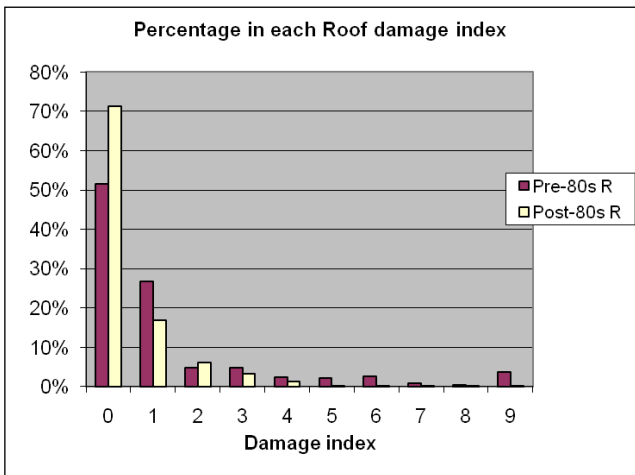
Figure 3: Damage to roof

Most of the contemporary houses (Post-80s) were slab-on-ground houses, with reinforced masonry walls. Figure 3 shows that more than 70% of Post-80s buildings sustained no roof damage compared with just 50% of Pre-80s buildings. Significant roof damage has a Damage Index of 4 or more with the Pre-80s buildings consistently having a greater frequency of severe roof damage when compared with Post-80s buildings. These results from the street survey are the average across the whole study area, and show that around 12% of Pre-80s buildings sustained

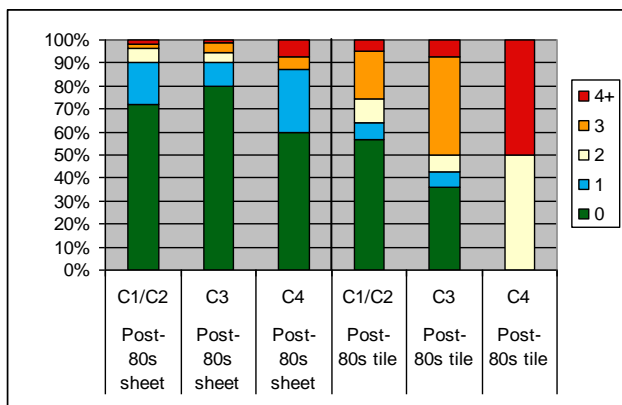
Figure 5: DI for sheet and tile post-80s roofs (Refer Table 1 for Damage Index values)

For Post-80s construction, damage to tile roofs was overrepresented when compared to other forms of roofing. Figure 5 shows the poorer performance of tiles compared to sheet roof for various AS4055 wind speed classifications (associated with exposure and topography). Failure modes of the tiles were loss of ridge capping (both apex and hip tiles), loss of tiles near gable ends, and cut tiles associated with hips. On most houses that had lost ridge capping, no mechanical fixings such as clips or screws on the ridge tiles were observed (Figure 6). The fixing method appeared to be flexible pointing adhesive. Examples were noted of failed or dislodged tiles that had clips attached to battens. It is unknown if the clips were correctly engaged with the tile prior to the wind loads or if the tiles disengaged during the wind loading. The dislodgement of the ridge or other tiles generally led to additional damage to the tile roof and to adjacent structures through wind-borne debris. The study has shown that improvement is required in fixing practices of roof tiles.
