Windstorms in Victoria and Southern NSW – March 21, 2013

J.D. Holmes¹

Abstract

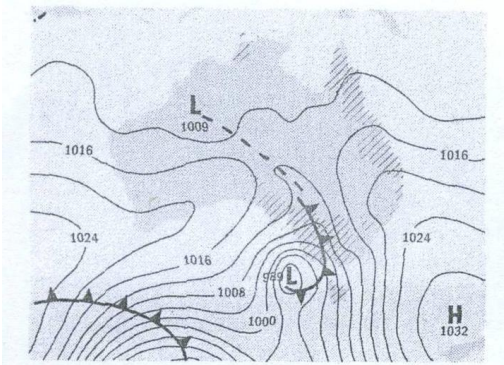
The isobaric chart for south-eastern Australia for 9a.m on Thursday March 21st 2013 (Figure 1) indicated strong northerly winds, followed by an approaching cold front and a low-pressure system, but was otherwise relatively benign with little indication of severe storms to come.

Figure 1. Isobaric chart for 9a.m., 21-3-2013

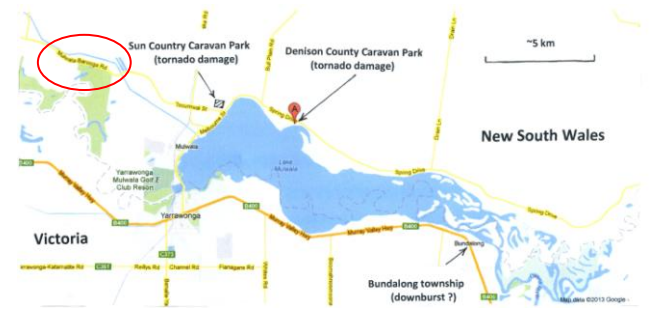
Figure 2. Damage sites near Lake Mulwala (NSW-Vic border) (the red ellipse indicates the road from which a close-up video of the tornado was obtained)

A video of a tornado travelling east was made from a car on the Mulwala-Barooga Road (indicated by the red ellipse in Figure 2), and made available on ‘You-Tube’. This was almost certainly the same event produced the extreme damage at the two caravan parks.

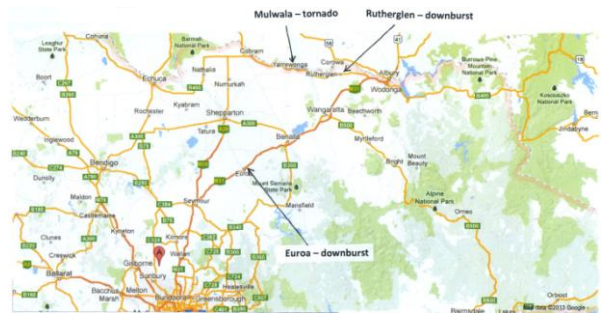
Other isolated severe winds occurred at Rutherglen - centre of a wine-producing region further up the River Murray from Lake Mulwala - and near Euroa, Victoria about 100 kilometres to the south east (Figure 10).

Figure 10. Damage sites in north-east Victoria
