Damage surveys following the Hobsonville Tornado in Auckland and Tropical Cyclone Evan in Samoa.

R. Turner¹, R. Paulik¹, G. Smart¹, J Bind¹, S. Gray¹, E. Yang¹, L. Asora², M. Leiofi², and R. Flay²

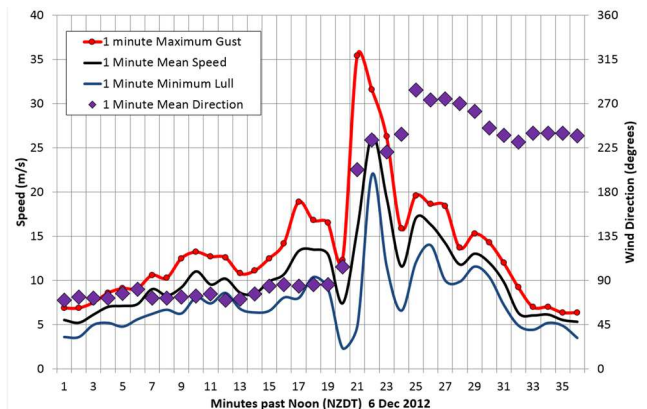
Figure 1. Time series of 1-minute maximum 3-sec gust, mean speed, and 3-sec lull and mean wind direction between 12:01 and 12:36 pm NZDT December 6, 2012 for Whenuapai AWS (Note: NIWA Climate Database Agent Number 23976; anemometer location 36°47'12.03' S, 174°37'53.68' E; station elevation 23 m.)

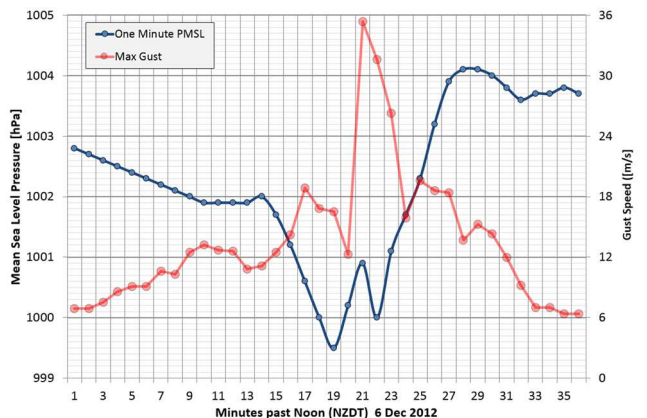
Figure 2. Time series of 1-minute mean-sea level pressure between 12:01 and 12:36 pm NZDT December 6, 2012 for Whenuapai AWS. The maximum gust series is also displayed for ease of comparison with other figures.

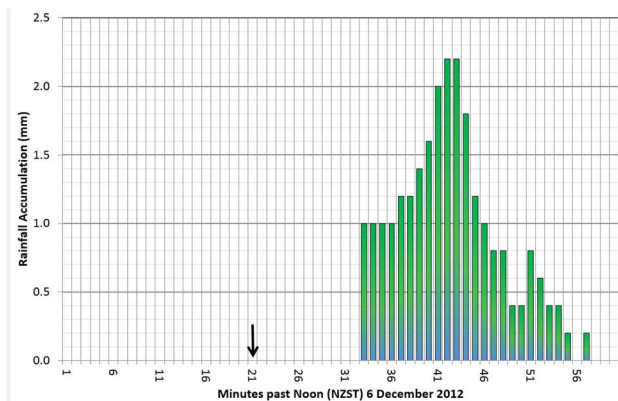
Figure 3. Time series of 1-minute rainfall between 12:01 and 1:00 pm NZDT December 6, 2012 for Whenuapai AWS. The arrow indicates the time of peak maximum gust.

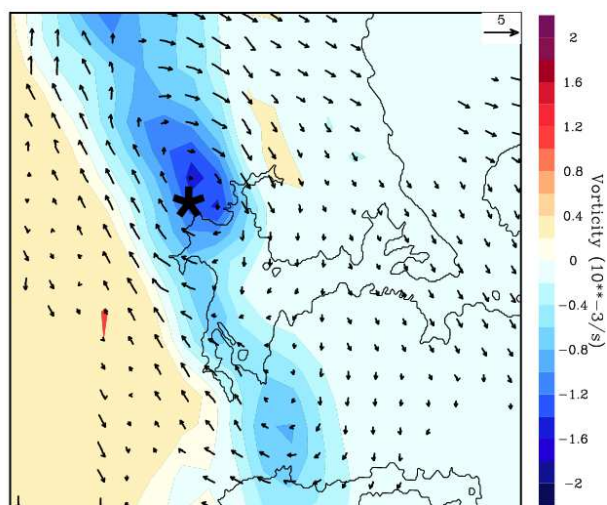
Figure 4. Wind vectors (m/s) at 600 m agl relative to storm motion (12 m/s from NW) and relative vorticity (s^{-1}) for 12:30 pm NZDT Dec 6, 2012 as forecast (Initial time 06:00 NZDT Dec 6, 2012) by NZCSM model. Hobsonville's location is marked by the black asterisk.

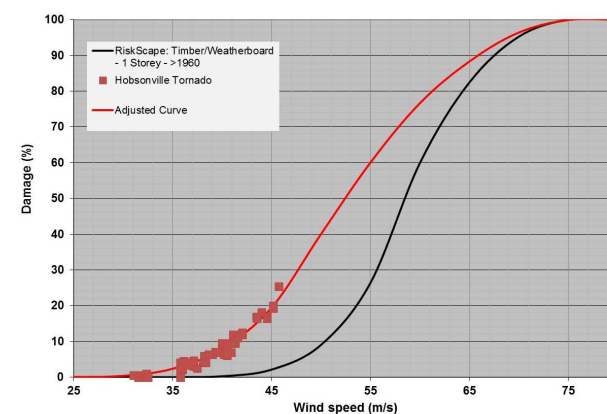
Auckland City asset database within RiskScape to estimate probable losses and casualties. This calibration exercise revealed that when using the existing damage curve the estimated damage was much lighter than observed. So a new damage curve for weatherboard, post 1960 houses has been developed based on the data collected (see Figure 6). Similarly losses seem much less than provisional insurance estimates (\$300,000 as opposed to \$10 million). Part of this is likely due to the high proportion of water damage, and to issues in how NZDF assets are represented in the database, but most of the discrepancy can be attributed to an overly-conservative damage state curve. Previous curves have been developed from damage by straight line winds and this highlights the need to have separate damage curves for tornadoes. It was also noted that separate casualty functions also need to be developed and applied due to the fact that there is little warning for tornadoes (in NZ) and these cause most wind related fatalities whereas for extreme gales where there is more warning fewer people are outside (the fatalities here and in Albany in 2011 were all at construction sites).

Figure 6. Wind damage curves for post 1960 timber weatherboard 1-story houses as used in RiskScape (Black line) and as derived for the Hobsonville Tornado (Red curve).

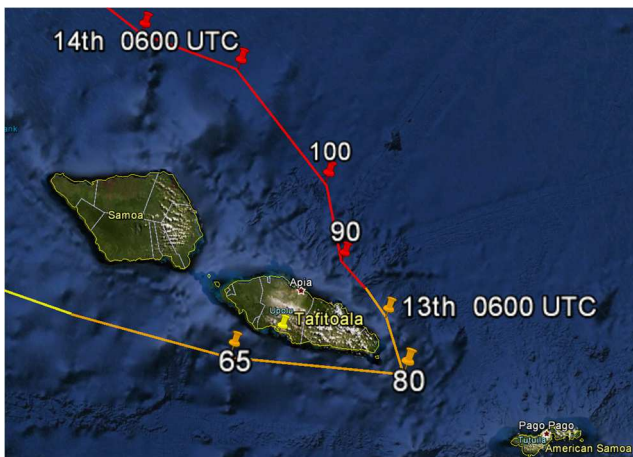
Tropical Cyclone Evan (track shown in Figure 7) developed from a tropical disturbance that first formed about 600 km west of Samoa on December 9 with Category 1 (Australian Tropical Cyclone Intensity scale) winds first estimated at 1800 UTC 11 December, 2012 (0800 LST 12 December, 2012) when the storm was 400 km west of Apia. TC Evan rapidly moved eastward at 22 km/hr and strengthened to 65 knots (TC 3) by 1800 UTC on the 12th, it continued to strengthen to 80 knots but its eastward movement slowed and it turned sharply to the NW at 0000 UTC on the 13th after it had passed the eastern end of Upolo. Here central pressures were estimated to be about 963 Hpa and deepening. Evan strengthened further as it moved NW and became Category 4 by 1200 UTC on the 13th when the centre was about 20 km NE of Apia. Peak gusts of up to 113 knots were reported around then. While TC Evan did not make landfall as it passed Samoa, significant wind damage occurred in the areas of Tafitoala and Si'umu villages on south coast during the afternoon of the 13th (around the time TC Evan made it's sharp North-west turn), with the most extreme damage (see Figure 8) caused by tornadoes (eyewitness reports) during a period of a two-three hours of very heavy rain, low visibility and very strong winds off the sea. Damage further east along the coast and also at higher altitudes away from the coast was not as severe and less widespread. TC Evan also caused a major and damaging flood of the Vaisigano River in Apia. Only minor storm surge was reported and this did little damage.

Figure 7: Track of TC Evan centre in the vicinity of Samoa on Google Earth map for 13th and 14th December 2012. The coloured pins mark positions 6 hours apart, the orange colours highlight parts of the track in which TC Evan was TC 3, and Red when it was TC 4. Estimates of peak sustained speeds (in knots) at position of pins are also shown. The position of Tafitoala is shown, Si'umu is about 4km east along the coast. These villages are where wind damage was most severe on Upolo and where the wind-damage survey efforts were concentrated.
