Fastener Pull-out Tests to Determine Threshold Values for Roof Failure Modes Observed After Typhoon Haiyan in the Philippines

J.Y. Hernandez Jr.¹, H.O. Bisa¹, R.E.U. Longalong¹, R.M. Suiza¹, and C. Orozco¹

Abstract

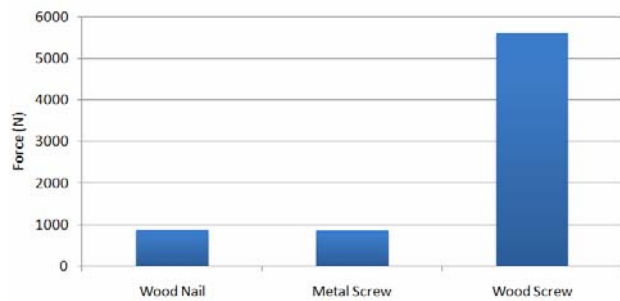
Figure 16. Comparison of Average Resistances between Different Fasteners

Figure 16 shows the FPR (Static loading), wood screw has the highest (5.5 kN) while wood nail and metal screw are the almost the same (0.9 kN). Figure 17 shows the decrease on FPR due to 1500-2000 cycles for wood nail, metal screw and wood screw was 2.8%, 9.4% and 23% respectively. The mode of failure in the roofing connection depends on what type of fastener is to be used shown in Table 2.

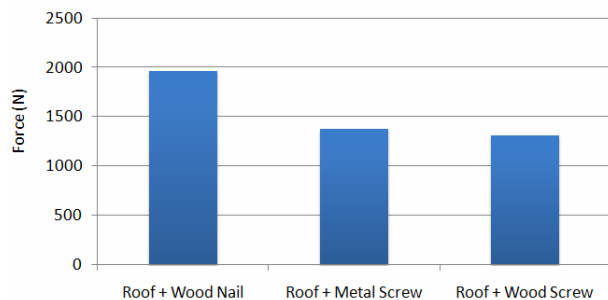
Figure 18. Comparison of Average Maximum Loads on Roofing Test

These results show that the high pull-out resistance of the wood screw is not achieved because tearing failure of the G.I. sheets controls the mode of failure. Whereas the wood nail does not allow tearing failure because of its wide head. However, its low FPR caused a pull-out mode of failure.
