A Coastal Microburst Wind Damage Survey and Observations

M.J. Glanville¹ and N.A. Moir²

ABSTRACT

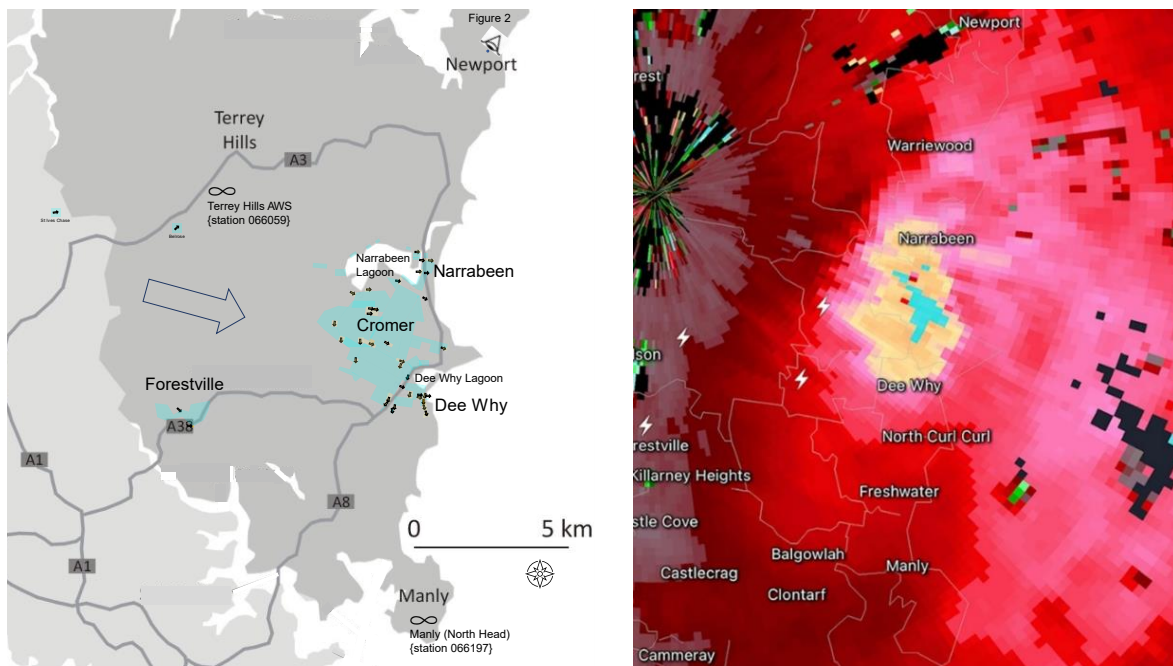
Figure 1. Sighted storm damage locations on Sydney Northern Beaches (L). Bureau of Meteorology via RadarScope velocity doppler radar image 15:34 19th December 2021 (R).

A series of thunderstorms formed over the Northern Beaches initially causing localised damage at Forestville before forming a microburst over Narrabeen lagoon. Rapid intensification is observed around 15:34 in velocity doppler images of Figure 1 with exceedance of the Terry Hills Nyquist velocity 94 km/hr.

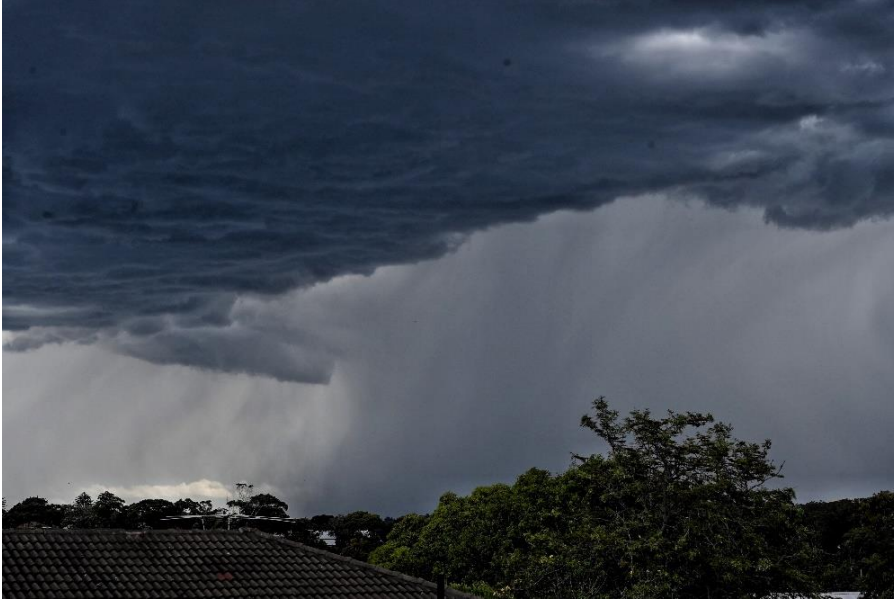
Figure 2. Narrabeen Lagoon microburst photographed from Newport by Moir² 19th December 2021

The Narrabeen Lagoon microburst was captured in a sequence of photographs by Moir² taken from an apartment building rooftop in Newport, Figure 2. At 15:25 air in the vicinity of Narrabeen Lagoon is seen to updraft into the string flat base to the shelf cloud on the left side of the photo. Evaporation of rain falling into the dry cold front air (centre photo) further cools and increases air density thereby accelerating the downdraft vertically resulting in the microburst seen at 15:33 and 15:34, with outflow moving toward the left (note photo viewing angle in Figure 1).
