Probabilistic Failure of Roof Elements in Wind

Graeme Beattie¹

¹*Fire and Structures Group, BRANZ Ltd, Judgeford, Porirua, New Zealand,
graeme.beattie@branz.co.nz*

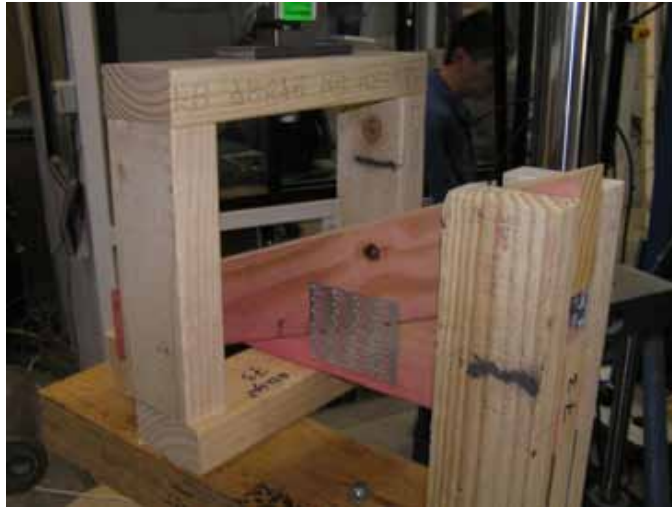
Fig. 1 Sample test setup in the test machine

All of the tests were conducted in the Dartec Universal Test Machine in the BRANZ structures laboratory. The loading rate was set at the fastest speed that the machine could operate (600mm/s) to simulate the likely wind force in the field. An example of a truss/top plate test setup is given in Fig. 1.

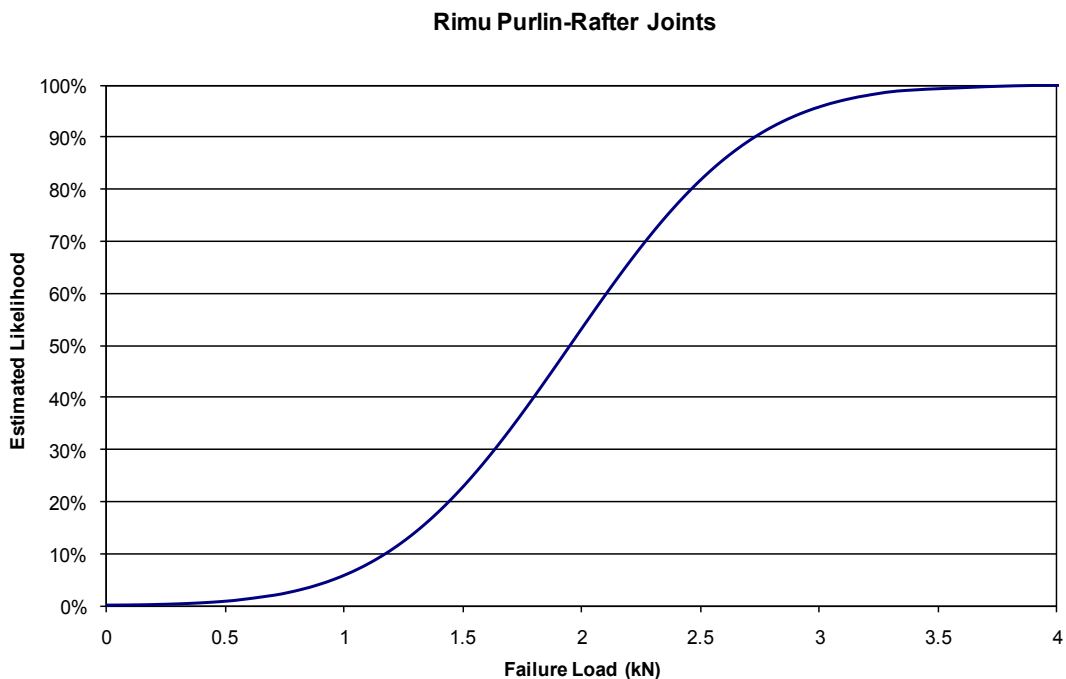
Fig. 2 Sample plot of the likelihood of failure

Various distributions were tested against the results of the tests. Generally, a normal distribution was found to provide a reasonable fit to the data and then from this a plot of the likelihood of failure (as a percentage) was made against the range of failure loads (the fragility curve). A sample plot of the fragility curve is presented in Fig. 2.
