Improving the Wind Resistance of Australian Legacy Housing

D.J. Smith, D.J. Henderson and J.D. Ginger

Cyclone Testing Station
James Cook University, Townsville, Queensland 4811, Australia

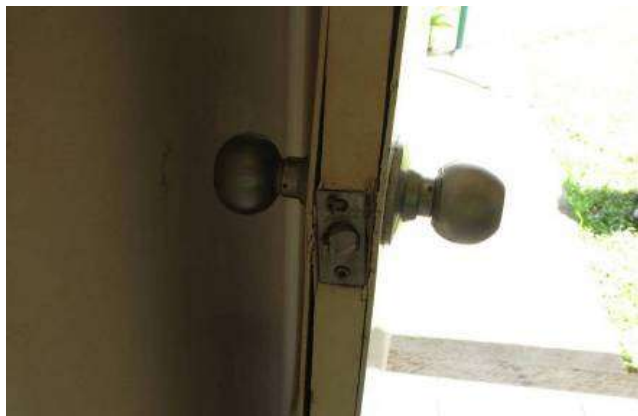
Figure 3. Typical lock and damaged door after being blown inward during Cyclone Yasi in 2011.

Maintaining a sealed building envelop is critical to the wind resistance of structures. If there is a breach on the windward face, (i.e., from broken window or failed door) (Figure 3), the internal pressure of the house can be dramatically increased. The internal loads act in concert with external pressures, increasing the load on cladding elements and the structure envelop. Depending on the

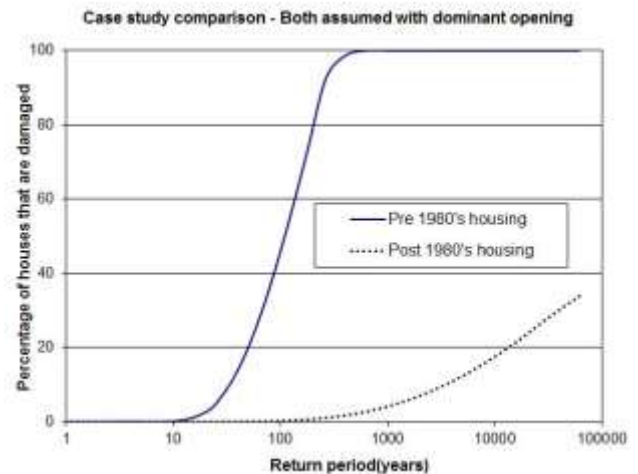
Figure 4. Vulnerability curves for pre-1980s and post-1980s residential structures with increasing return period (King et al, 2013).

AS/NZS 1170.2 provides information for selecting the design wind speed related to the return period. Using vulnerability curves developed by CTS, Figure 4 shows the percentage of housing damaged versus the return period for a typical cyclonic region C, suburban site. These curves show the significant decrease in damage to housing that could be achieved if pre-1980s houses were upgraded to the wind resistance of contemporary post-1980s houses.
